**Resilience and Repair of Major Steel Bridges**

December 2, 2021

# Resilience and Repair of Major Steel Bridges

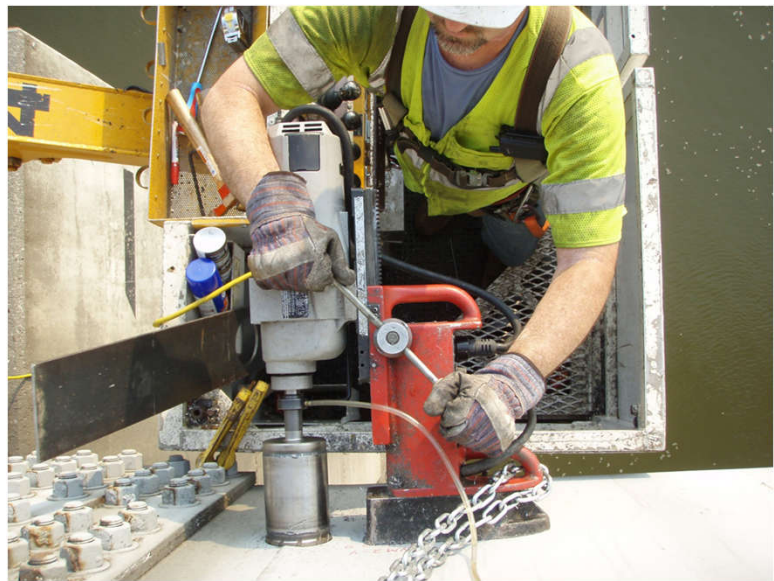
### Enhanced Inspection / Preemptive Retrofit

Core the plates and welds and  
test the materials

Over 300 individual tests were  
conducted

Conclusion - steel is  
susceptible to fracture at mild  
temperatures in the presence  
of cracks we suspected were  
out there

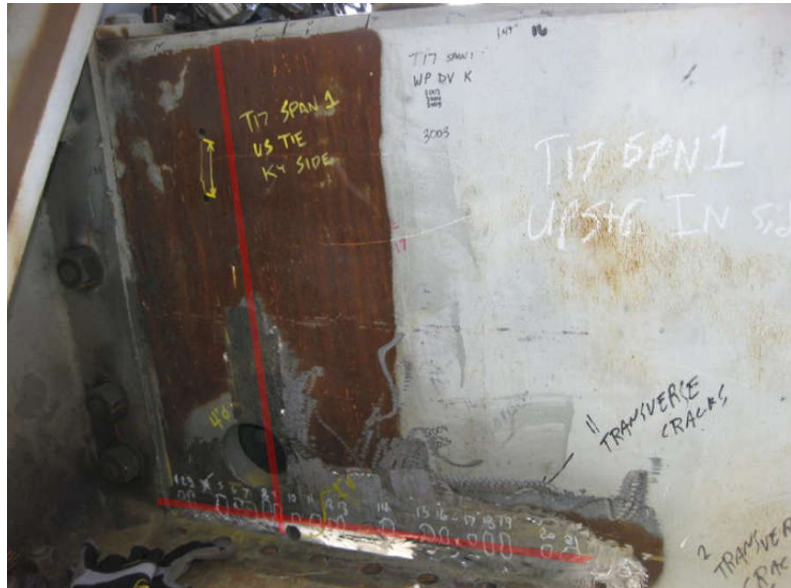
### Lateral Bracing Plates

In this connection alone, over 20 cracks were "hiding" behind the connection plate.

Only several days into the preemptive retrofit, the bridge was closed.

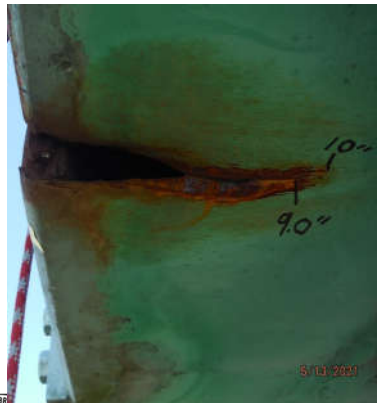
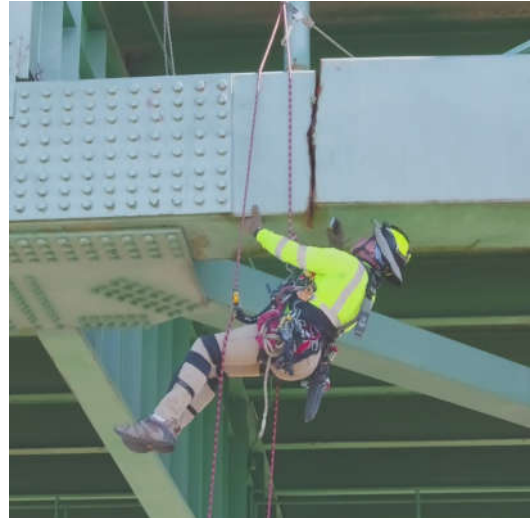
## Closer Look at Fracture

- Condition
- Measurements

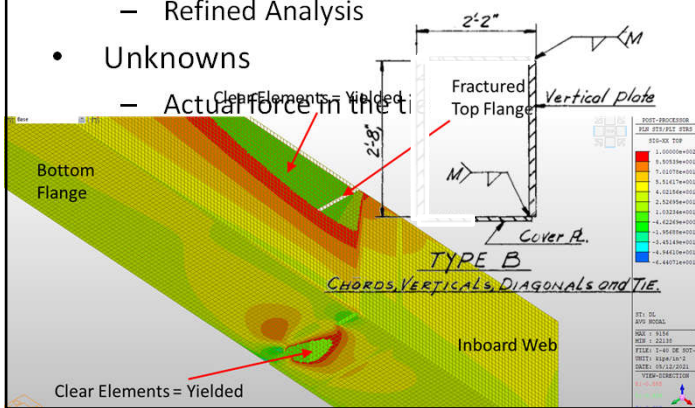
## How Bad is it?

- T1 steel = 100 ksi (+)
  - P/A deadload = 38ksi
- Fracture 113 in<sup>2</sup> -> 51.5in<sup>2</sup> (**45%!)**
  - P/A after Fracture = 83ksi
- Eccentric Loading
  - Refined Analysis
- Unknowns
  - Actual force in the tie

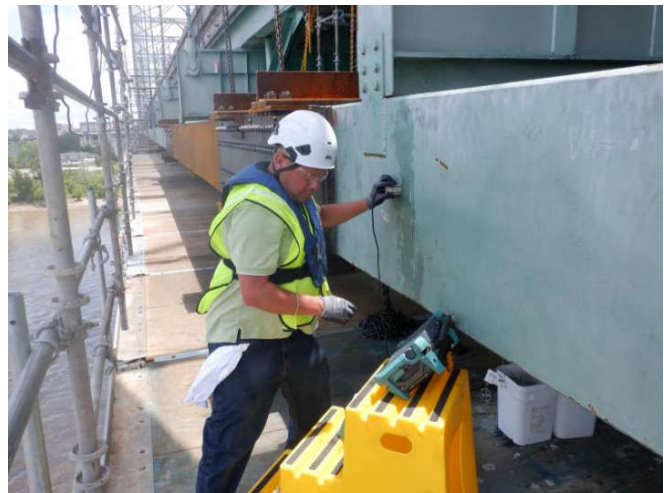
NDT Inspection of Arch Tie Member

- Full Penetration Butt Weld detail typical throughout structure
  - Potential for similar defects
  - Prevent future failure
- Arch Tie Members and Hanger Pins (Approx. 500 welds)
  - HNTB contracted CAN-USA
  - June 9<sup>th</sup> to June 17<sup>th</sup>
- Arch Truss Members MBI contracted Fickett
  - June 7<sup>th</sup> to June 11<sup>th</sup> and June 23<sup>rd</sup> to 25<sup>th</sup>

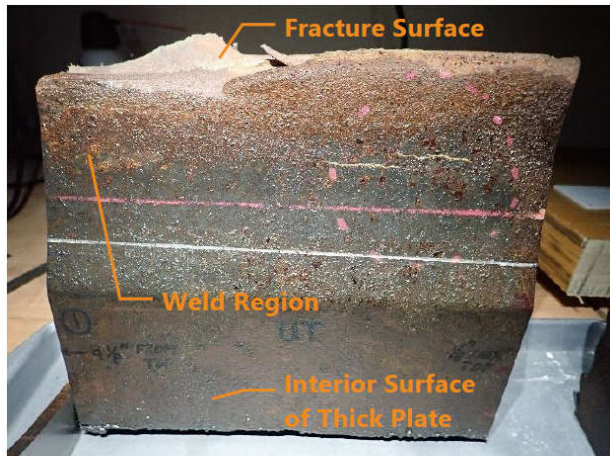
Figure 1. Sample under white light showing MT filings at crack locations.

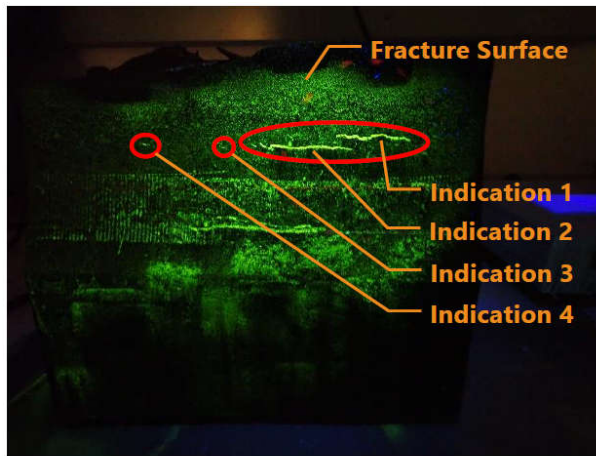
Figure 2. Sample under black light during wet fluorescent MT inspection with four MT indications (red circles)

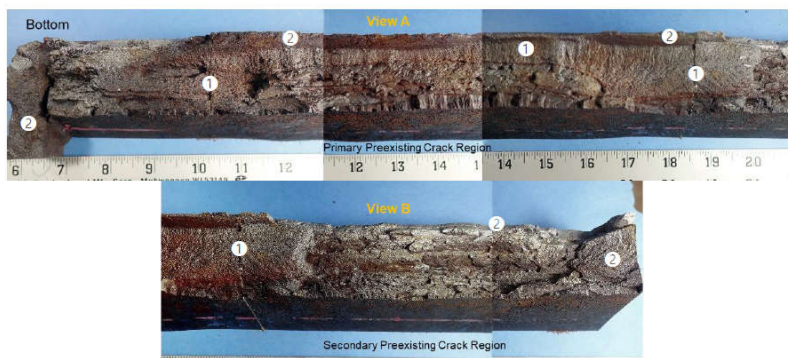
Figure 21. Higher magnification of the two preexisting crack regions after cleaning (1 first fracture and 2 second fracture).

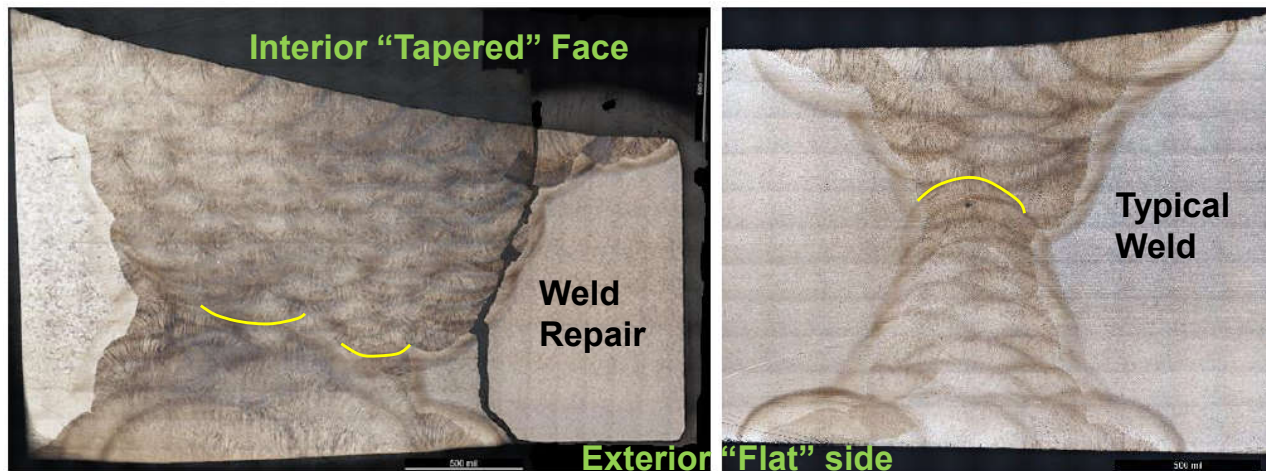
Figure 39. Primary preexisting crack weld profile.

Figure 40. Core Sample SA008E weld profile.

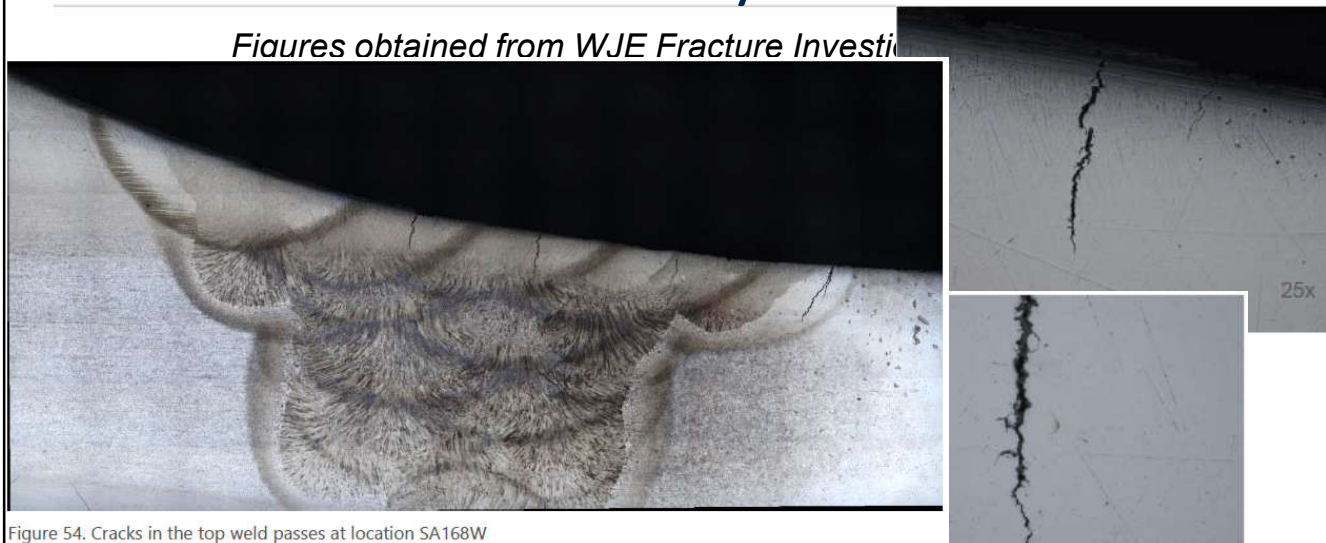
Figure 54. Cracks in the top weld passes at location SA168W

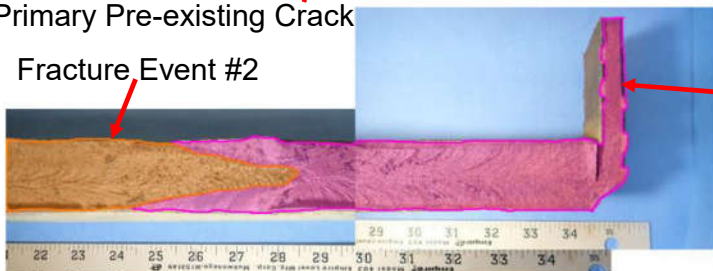
Figure 61. Lower portion of fracture, color-coded to indicate failure sequence.

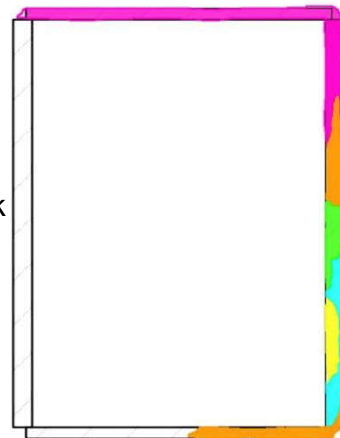
Figure 62. Upper portion of fracture, color-coded to indicate failure sequence.
