Resilience and Repair of Major Steel Bridges  
December 2, 2021

## Resilience and Repair of Major Steel Bridges

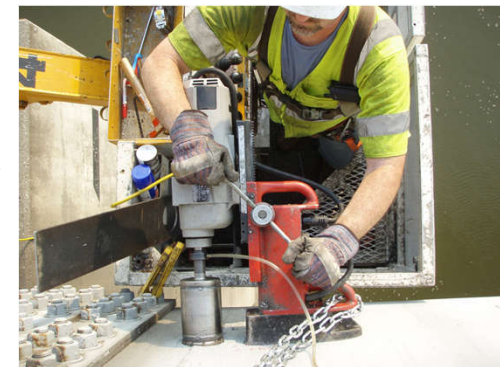
Core the plates and welds and test the materials

Over 300 individual tests were conducted

Conclusion - steel is susceptible to fracture at mild temperatures in the presence of cracks we suspected were out there

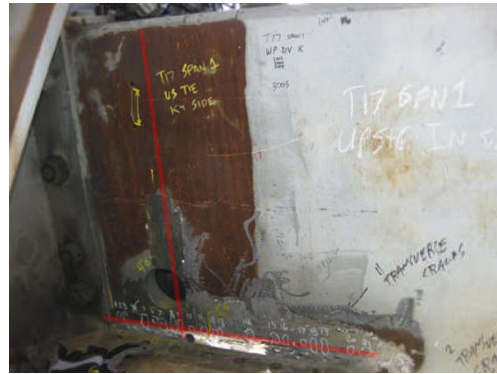
### Lateral Bracing Plates

In this connection alone, over 20 cracks were "hiding" behind the connection plate.

Only several days into the preemptive retrofit, the bridge was closed.

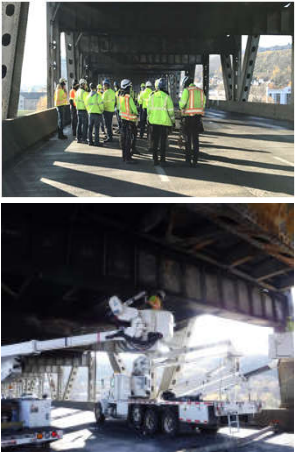
- 20 + Inspectors
- Structural Stability
- Damage in Heat Affected Zone
- Condition of Remaining Bridge

- Concrete Cores
- Steel Cores (Microscopic Eval)
- Laser Induced Breakdown Spectroscopy
- Telebrineller hardness

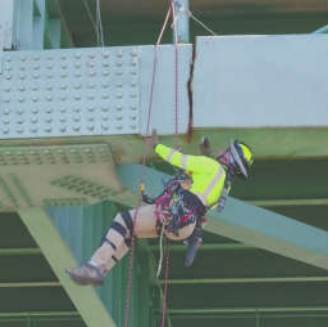
### Closer Look at Fracture

- Condition
- Measurements

- T1 steel = 100 ksi (+)
  - P/A deadload = 38ksi
- Fracture 113 in<sup>2</sup> -> 51.5in<sup>2</sup> (45%)
  - P/A after Fracture = 83ksi
- Eccentric Loading
  - Refined Analysis
- Unknowns
  - Actual force in the

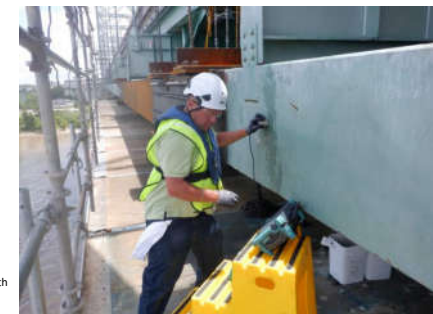
NDT Inspection of Arch Tie Member

- Full Penetration Butt Weld detail typical throughout structure
  - Potential for similar defects
  - Prevent future failure
- Arch Tie Members and Hanger Pins (Approx. 500 welds)
  - HNTB contracted CAN-USA
  - June 9<sup>th</sup> to June 17<sup>th</sup>
- Arch Truss Members MBI contracted Fickett
  - June 7<sup>th</sup> to June 11<sup>th</sup> and June 23<sup>rd</sup> to 25<sup>th</sup>
