The Structural Stability Game Show!  
September 25, 2020

## The Structural Stability Game Show!

### Case 1: Solar power support structure

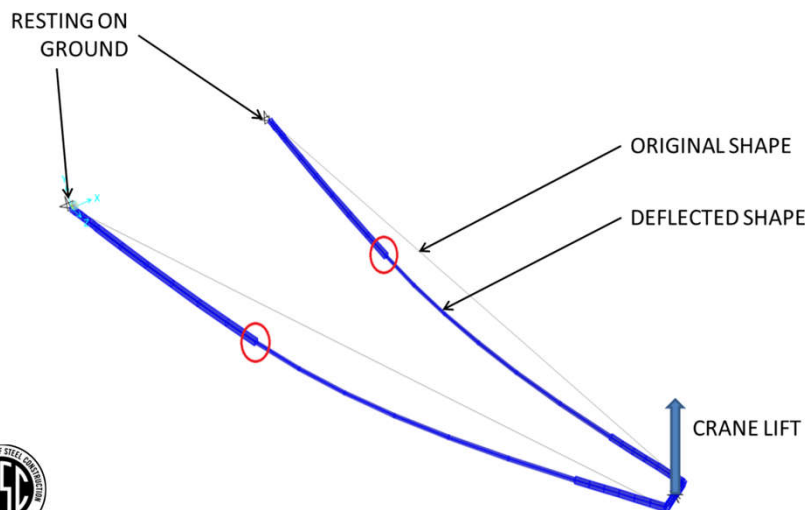
## Sufficient weld

max. moment at welds  
between upper and lower  
weldment is  
**95 kip-in.**

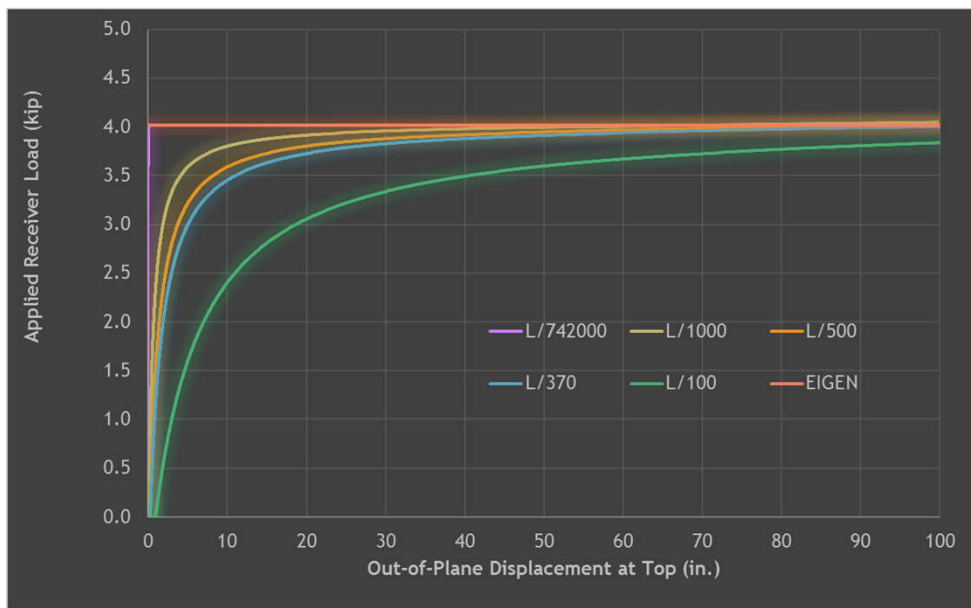
## Adequate design

Model	Top Bracing?	Total Load (kips)	
		Eigen	L-D
Case 1: Self-weight only	Unbraced	17.8	-
Case 2: Receiver + self-weight	Unbraced	6.1	5.6
Case 3: Receiver + self-weight	Fully Braced	30	-

weight of tower + receiver  
4.8 kips + 2.1 kips = 6.9 kips

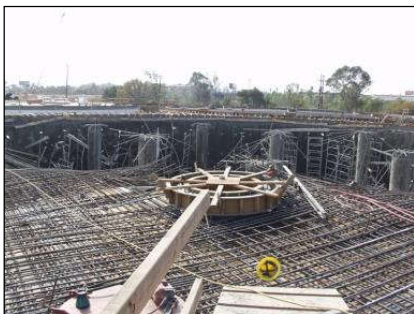
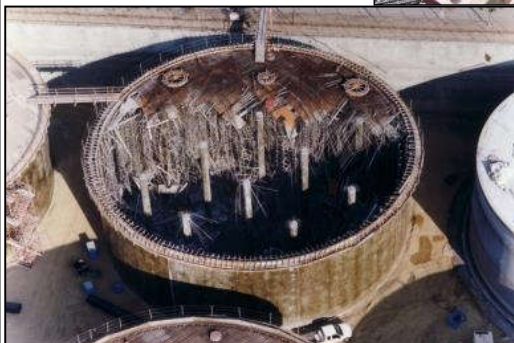
- Falsework supporting the plywood in Tank 19 collapsed
- 29 persons on the roof deck
- 14 workers injured; 4 serious; **none** fatally injured
- Tanks 19, 20, and 21 were immediately put under Cal OSHA Order to Preserve, pending investigation

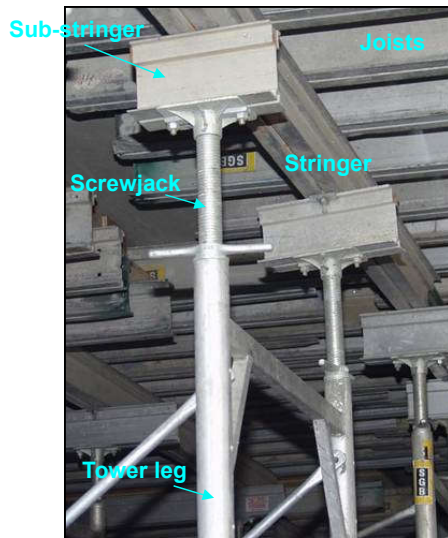
- Top and bottom of the towers had screwjacks for adjustable extension
- Many of the towers also had 12-inch or 16-inch long sub-stringers at the top

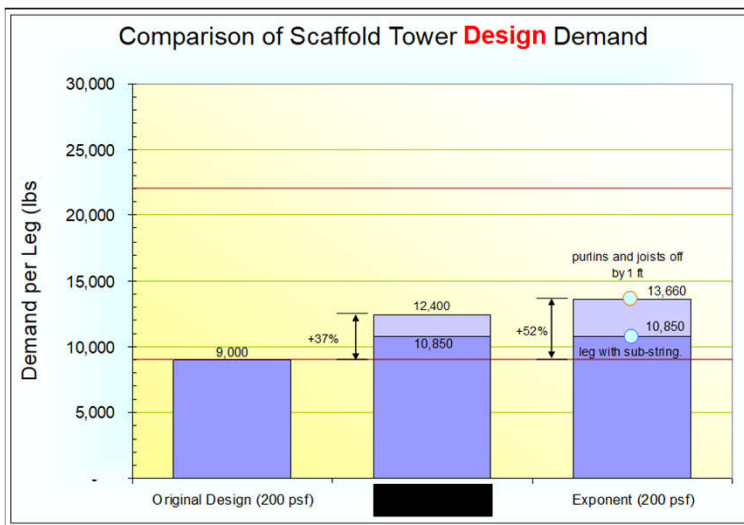
Design load included a 40 psf live load in addition to concrete and equipment weight

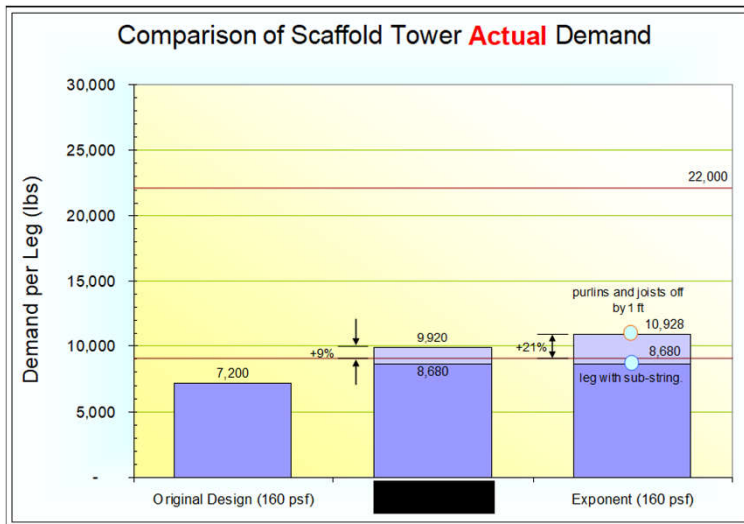
Actual loads still considerably higher than original design load of 9,000 lbs

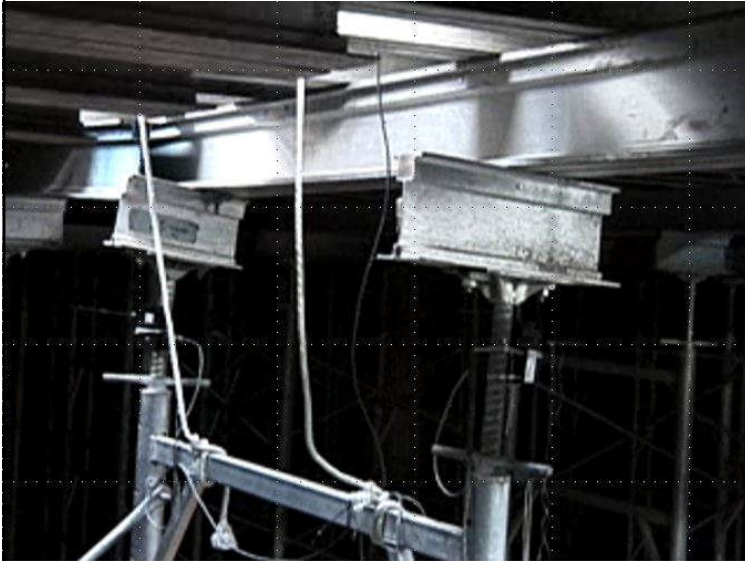
- Conducted full-scale field testing of exemplar shoring
- Towers were incrementally loaded to failure
- Failure due to sub-stringer web buckling leading to global buckling of scaffold towers
- The peak applied loads on legs with sub-stringers were
  - 14,850 lbs (Tower 1)
  - 13,750 lbs (Tower 2)
- Failure loads significantly below design ultimate of 22,000 lbs

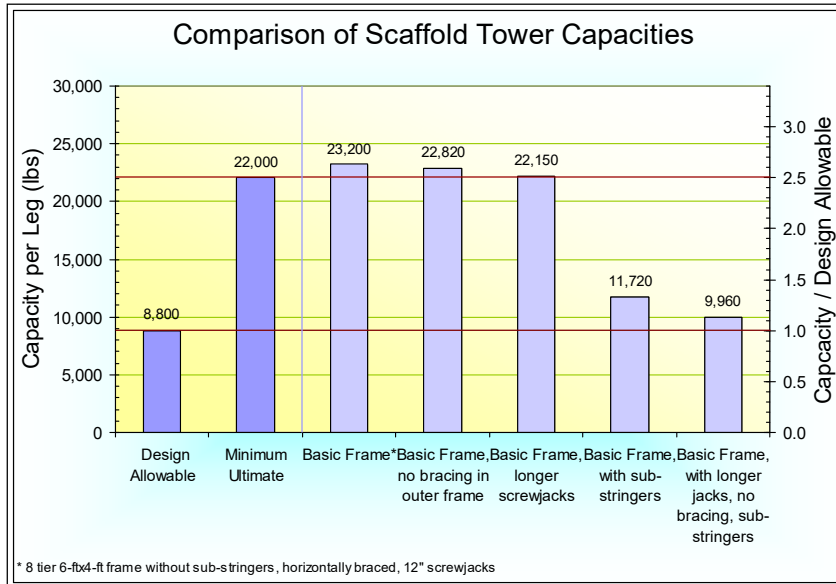
**Sub-stringers are the primary contributor to reduction in scaffold capacity**

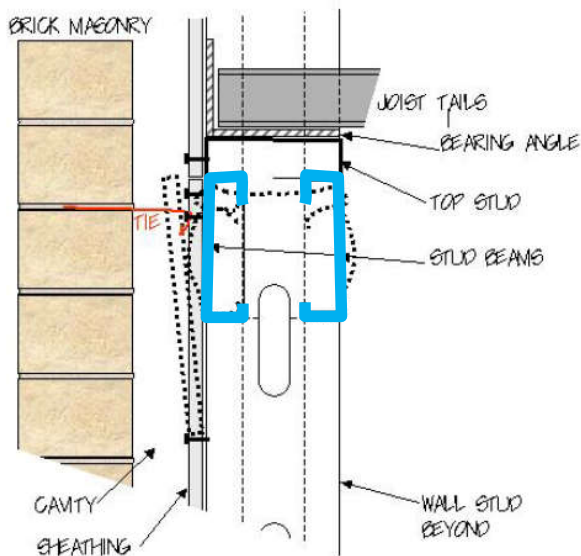
## Failure Mechanism – web crippling

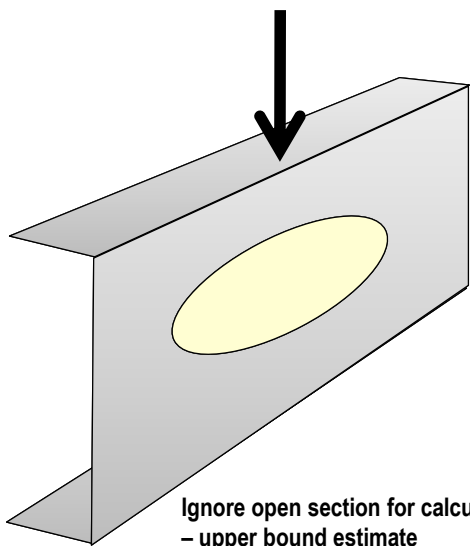
## Failure Mechanism – web crippling

Ignore open section for calculations  
 – upper bound estimate

Description	P (kip)
Allowable Load (ASD)	1.9
Exponent Calculated Capacity	3.5
Non-Factored Loads (service loads)	4.0
BOCA Requirements <sup>1</sup>	6.4
“Expert” Report	7.4 (??)

*Building Officials and Code Administrators requires assemblies to withstand 2.5 times live load for testing*
