AISC Live Webinars

The Structural Stability Game Show!
September 25, 2020

This webinar will feature a panel of engineers and academics, who will present their views on the root cause of three structural collapse case studies. The audience will then be given an opportunity to vote on which cause was most likely. Finally, the moderator will reveal and explain the true nature of the collapse.

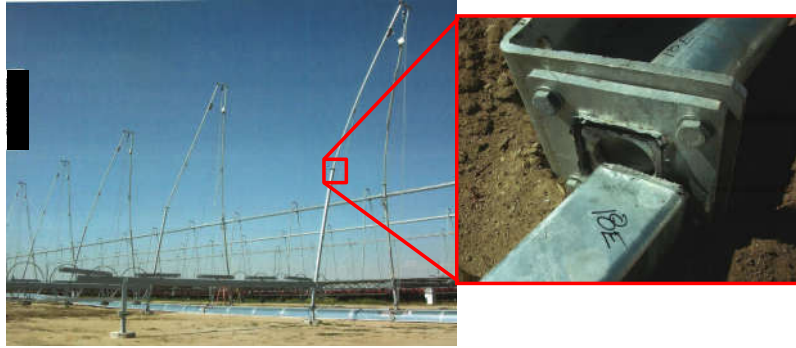
Background – The Failure

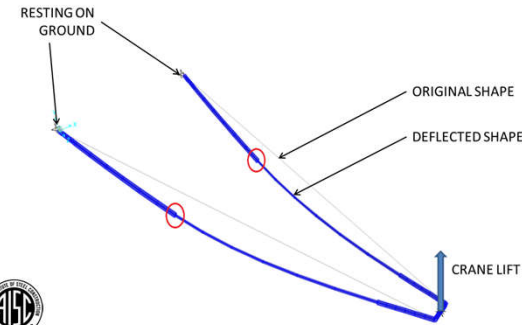
Sufficient weld

max. moment at welds
between upper and lower
weldment is
95 kip-in.

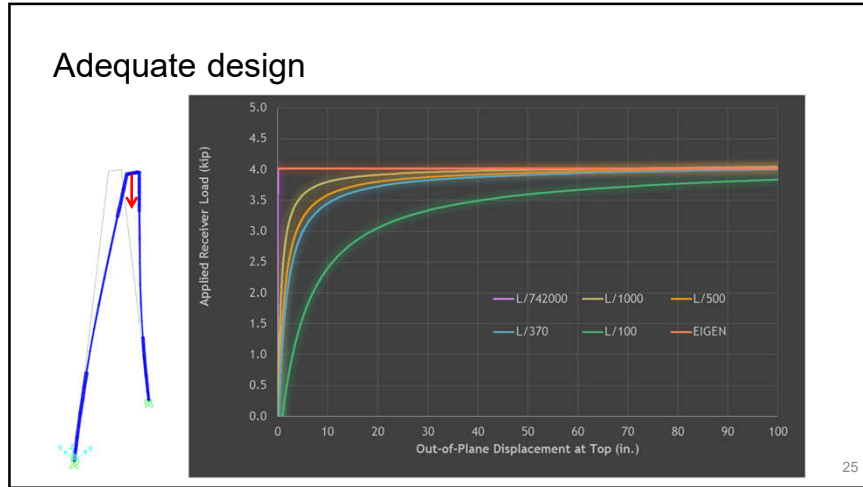
Adequate design

Model	Top Bracing?	Total Load (kips)	
		Eigen	L-D
Case 1: Self-weight only	Unbraced	17.8	-
Case 2: Receiver + self-weight	Unbraced	6.1	5.6
Case 3: Receiver + self-weight	Fully Braced	30	-

weight of tower + receiver
4.8 kips + 2.1 kips = 6.9 kips

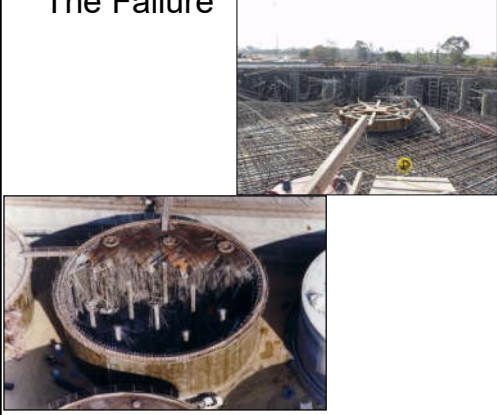
- Falsework supporting the plywood in Tank 19 collapsed
- 29 persons on the roof deck
- 14 workers injured; 4 serious; **none** fatally injured
- Tanks 19, 20, and 21 were immediately put under Cal OSHA Order to Preserve, pending investigation

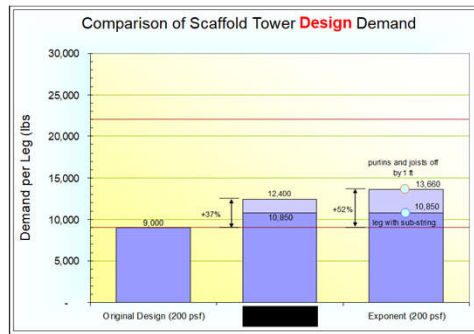
Design Loads (200 psf)

Design load included a 40 psf live load in addition to concrete and equipment weight

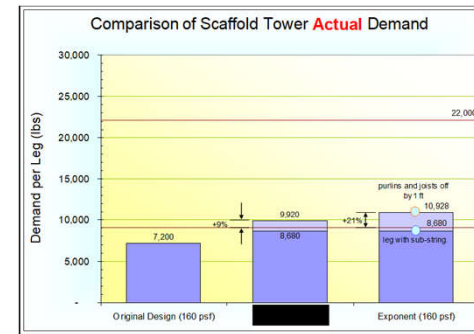
Actual Loads (160 psf)

Actual loads still considerably higher than original design load of 9,000 lbs

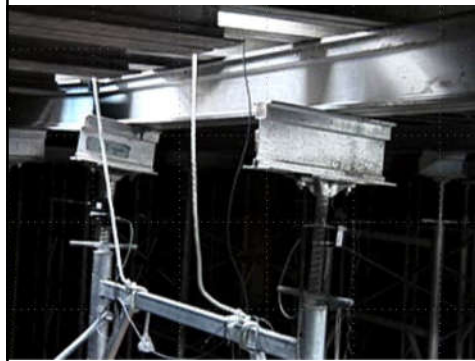
Full-Scale Field Testing

- Conducted full-scale field testing of exemplar shoring
- Towers were incrementally loaded to failure
- Failure due to sub-stringer web buckling leading to global buckling of scaffold towers
- The peak applied loads on legs with sub-stringers were
 - 14,850 lbs (Tower 1)
 - 13,750 lbs (Tower 2)
- Failure loads significantly below design ultimate of 22,000 lbs

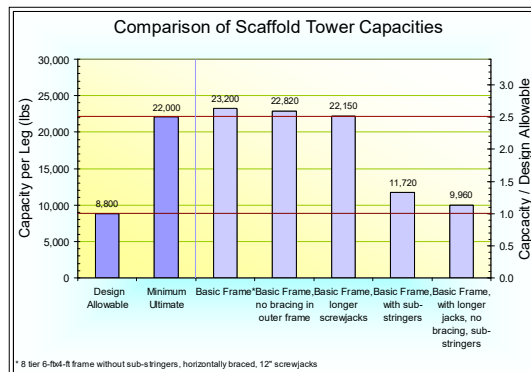
Sub-stringers are the primary contributor to reduction in scaffold capacity

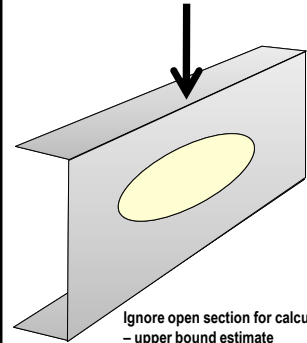
Failure Mechanism – web crippling

Ignore open section for calculations
– upper bound estimate

Description	P (kip)
Allowable Load (ASD)	1.9
Exponent Calculated Capacity	3.5
Non-Factored Loads (service loads)	4.0
BOCA Requirements ¹	6.4
“Expert” Report	7.4 (??)

¹Building Officials and Code Administrators requires assemblies to withstand 2.5 times live load for testing
