Brittle Fracture: Another View
April 19, 2022

This lecture examines brittle fracture from a holistic perspective, considering the many variables that lead to brittle fracture. Four case studies are used to illustrate the effect of these variables: the World War II Liberty Ships, the Silver Bridge, the Martha Ingram barge and the Hoan Bridge. The interaction of fatigue loading and fracture will be reviewed. Finally, 48 practical ideas that will increase the resistance of a structure to brittle fracture are presented.

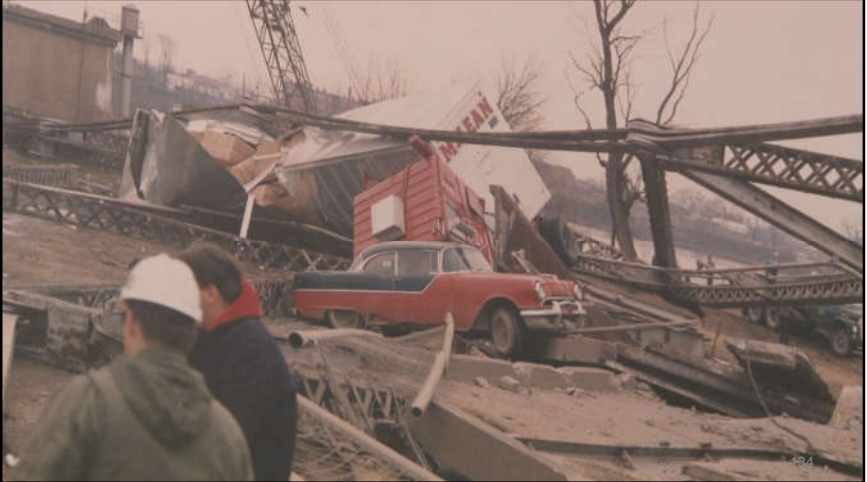
Silver Bridge Summary

- Opened to traffic May 1928
- Collapsed December 1967
- Eyebar suspension bridge
- 30 °F at time of collapse

- Total length: 1756 feet
- Main span: 700 feet
- River width: 1240 feet

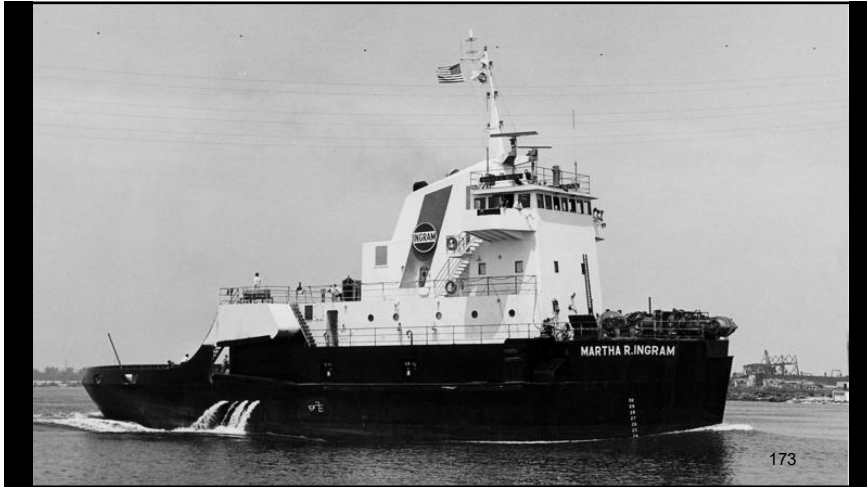
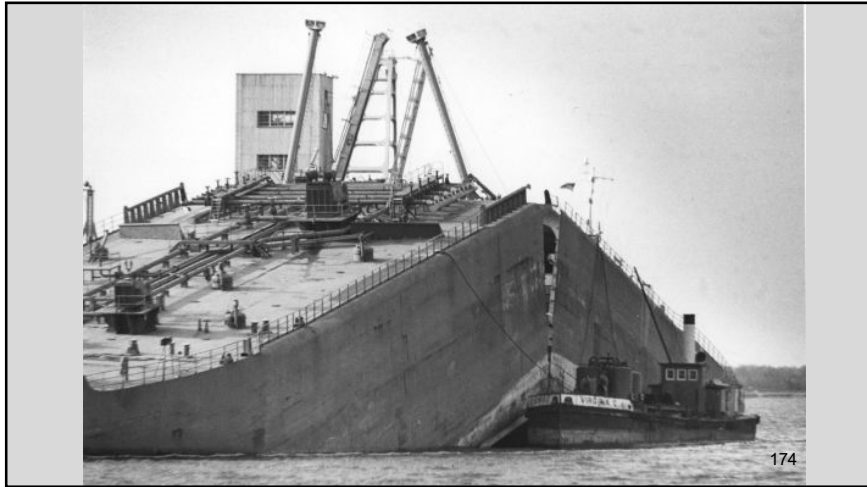
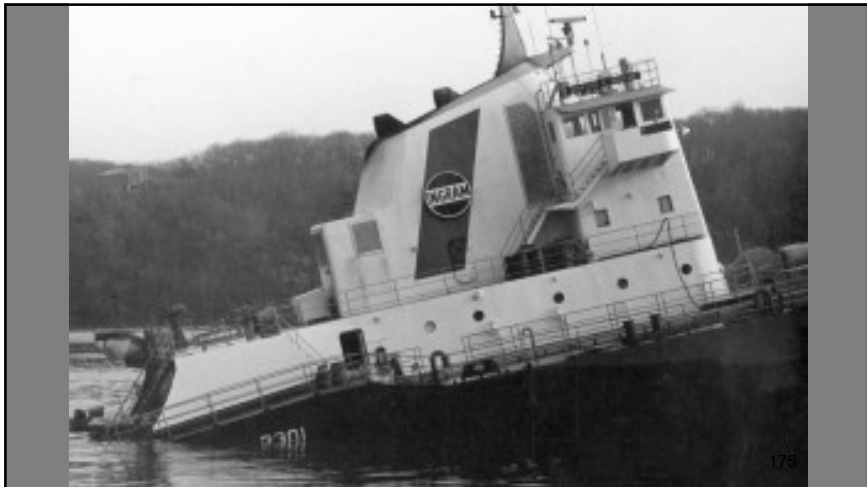
Martha R. Ingram Barge

- January 10, 1972
- 584 foot [178 m]
- Air temperature 45 °F [7 °C]
- In service for 9 months

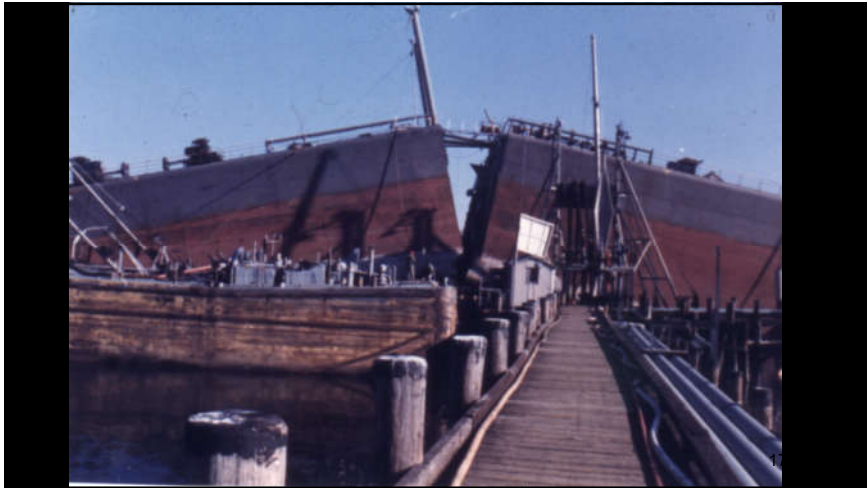
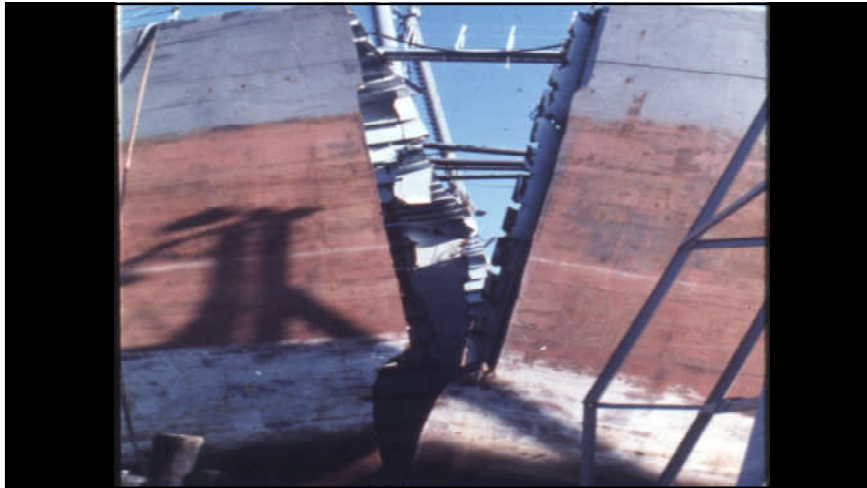
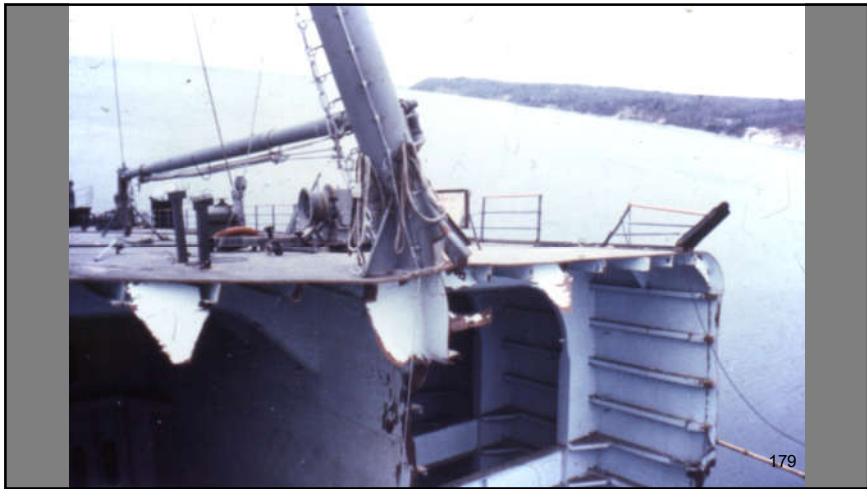
Martha R. Ingram Barge

- January 10, 1972
- 584 foot [178 m]
- Air temperature 45 °F [7 °C]
- In service for 9 months
- Unusual loading: 2.5X design load, 24 ksi [165 MPa]

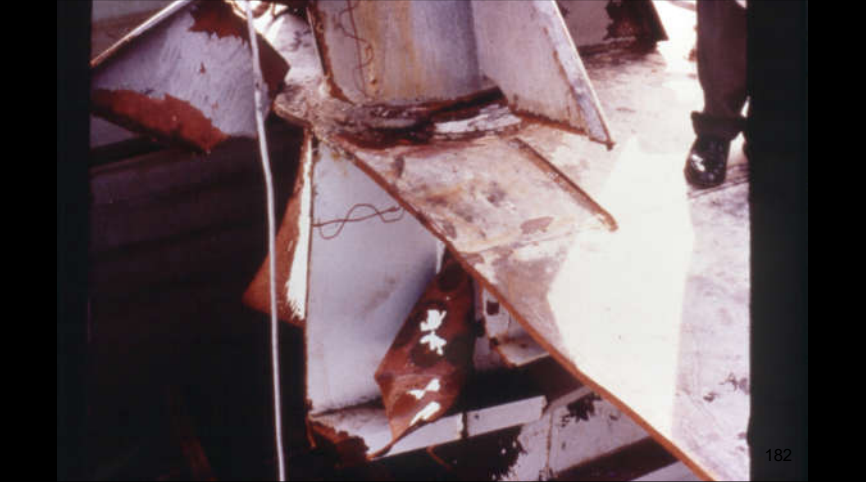
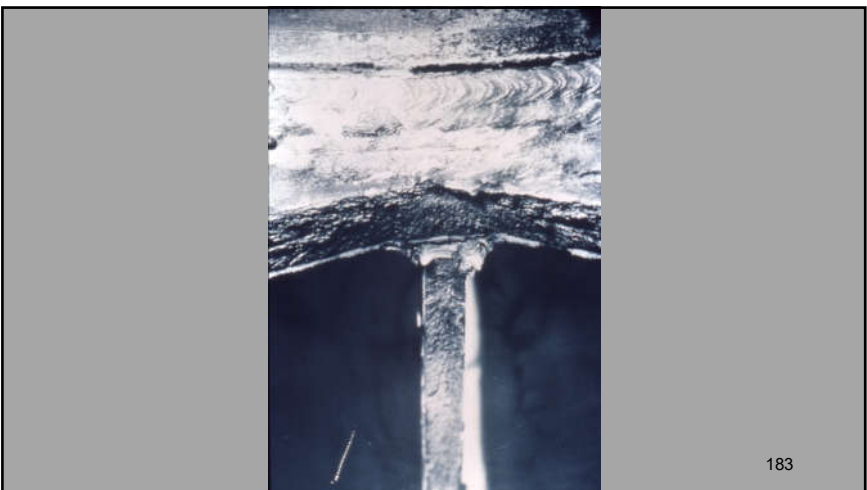
Martha R. Ingram Barge

- January 10, 1972
- 584 foot [178 m]
- Air temperature 45 °F [7 °C]
- In service for 9 months
- Unusual loading: 2.5X design load, 24 ksi [165 MPa]
- 55 ft-lbs [74 J] at service temperature
- No pre-existing flaws were observed

...the primary cause of failure was established to be an unusually high loading stress caused by improper ballasting at a highly constrained welded detail.

Thus, heavily constrained structures, such as the Ingram Barge, can fail under severe loads even though the inherent notch toughness and ductility may be very good. In contrast, well-designed simple structures can operate successfully at temperatures where their notch toughness may be very low. Thus, constraint and loading are the key factors in prevention of brittle fracture.

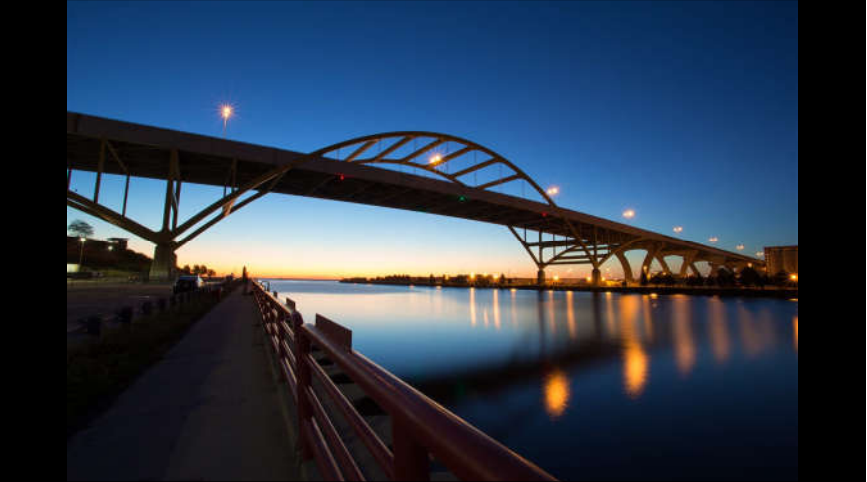
Hoan Bridge

- Built 1972, Opened 1977
- “The Bridge to Nowhere”
- Tied Arch
- Total length: 1.9 miles (3058 m)
- Longest span: 607 feet (185 m)
- December 2000: major fracture discovered
