The Use of NDT in the Rehabilitation of Major Steel Bridges: Two Case Studies

This webinar focuses on the rehabilitation of two major steel bridges, the Sherman Minton Bridge in Louisville and the Delaware River Bridge in Bristol, PA, each of which were rehabilitated and repaired using a combination of nondestructive testing, materials sampling and testing, engineering analysis, and emergency construction contracts. The two case studies show how major steel bridges can be quickly assessed and returned to service using a combination of tools.

Frank Russo, PhD, PE
Technical Director, Bridge Engineering
Michael Baker International
Philadelphia, PA

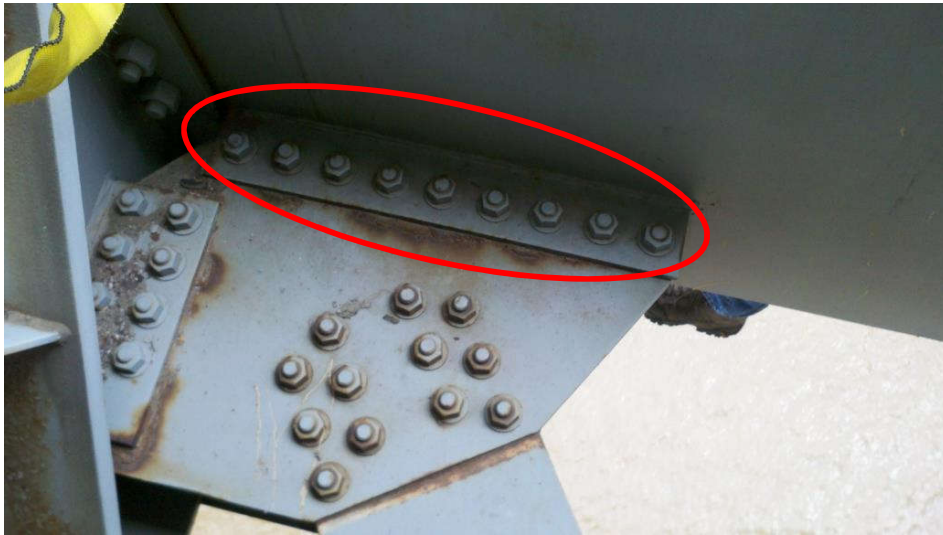
Lateral Bracing Plates

11 panels x 2 plates per panel x 2 ties x 2 spans = 88 connection plates

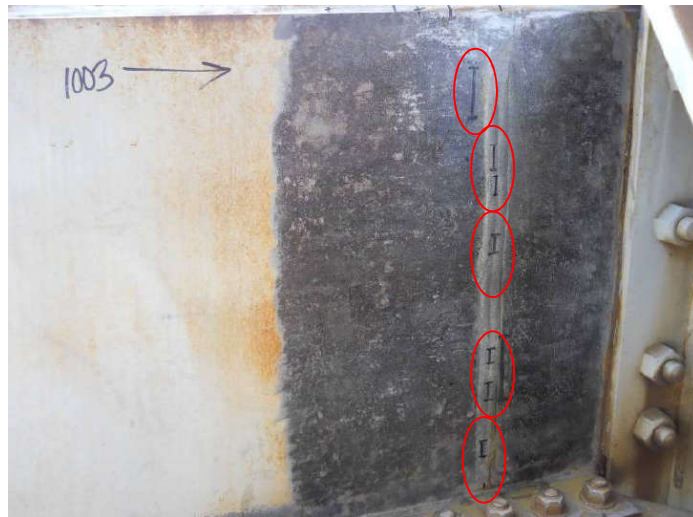
Tie Girder Welds

- It's what we CAN'T see that's the problem....

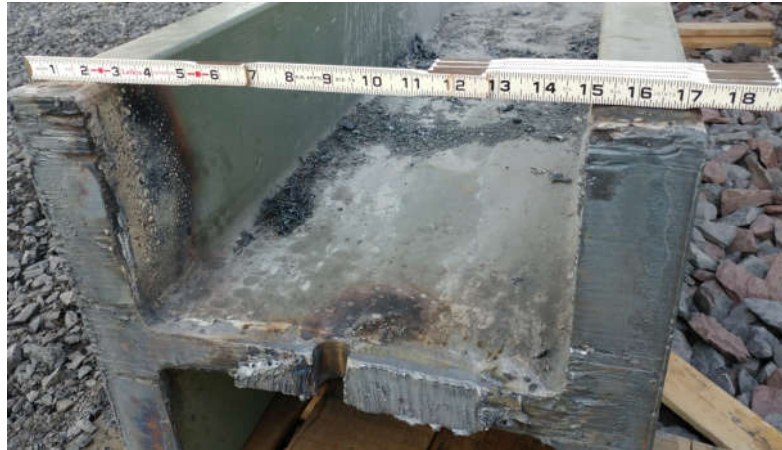
Fractured Chord After Removal

- W 14x314 Man-Ten Steel
- $t_f = 2.28''$
 $t_w = 1.41''$

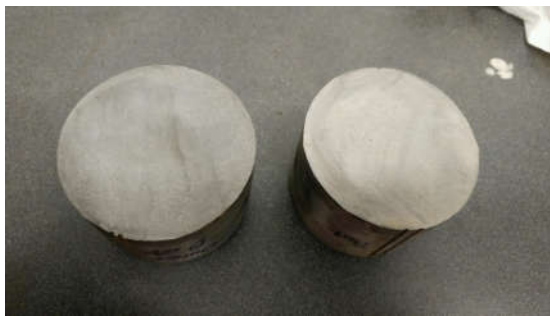
Removed Cores - Sectioned

- Two cores shipped to Purdue

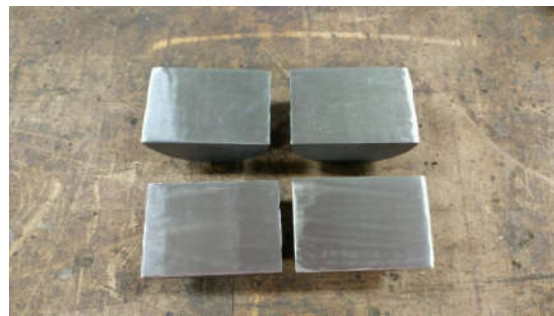
- Sectioned. No plug welds found

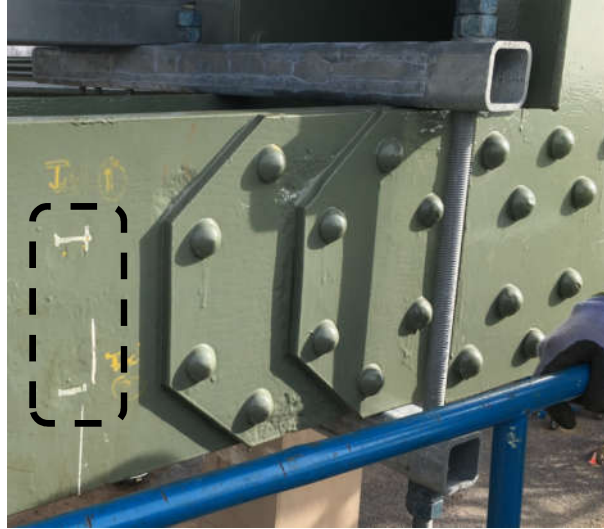
UT Indications @ L6-L8 PA 4-Span

- Possible filled holes found
- Gage line indicates possible filled holes

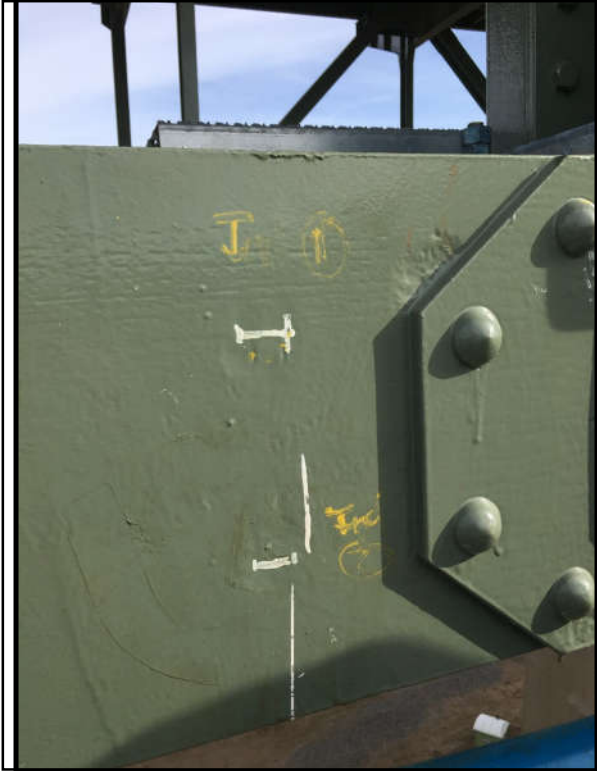
Filled Hole Investigation

A close-up photograph of a hole in a steel girder. The hole is filled with a dark material. The surrounding steel is dark and shows some surface texture. A bolt head is visible to the left of the hole.

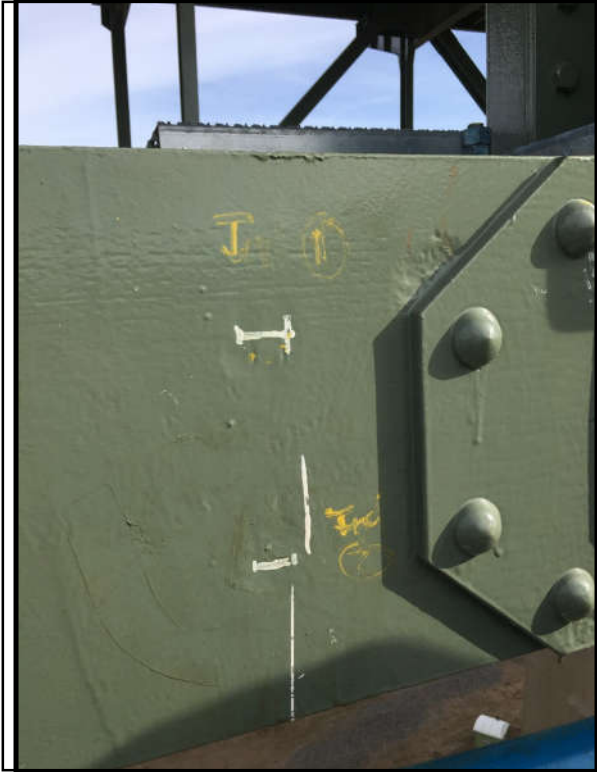
Filled Hole Investigation

A close-up photograph of two holes in a steel girder. Both holes are filled with a dark material. The surrounding steel is dark. A bolt head is visible to the right of the lower hole.
