AISC Live Webinars

The Structural Stability Game Show!
September 25, 2020

This webinar will feature a panel of engineers and academics, who will present their views on the root cause of three structural collapse case studies. The audience will then be given an opportunity to vote on which cause was most likely. Finally, the moderator will reveal and explain the true nature of the collapse.

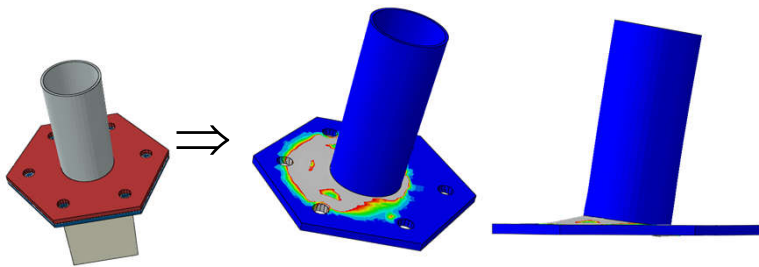
max. moment at welds
between upper and lower
weldment is
95 kip-in.

Sufficient weld

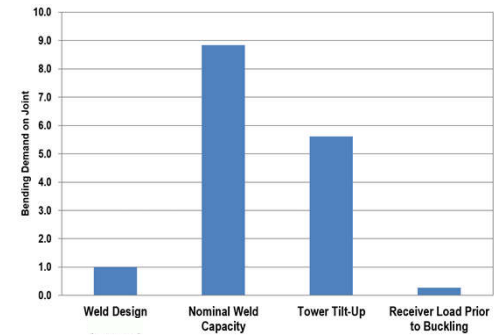
Sufficient weld

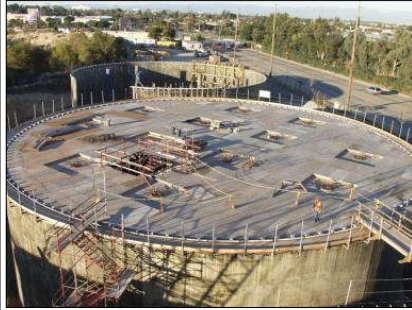
At the Time of the Accident:

- Tanks 17 and 18 had already been constructed; roof decks poured without incident
- Tank 19 was ready for concrete deck pour
- Tanks 20 and 21 had the falsework almost fully installed

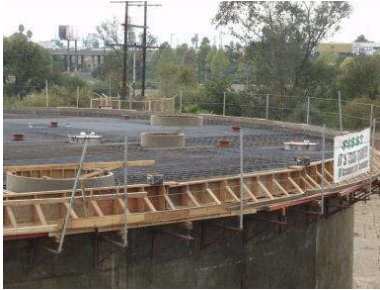
At the Time of the Accident:

- Concrete roof was being placed in Tank 19, moving south to north
- A little over half of the concrete had been placed

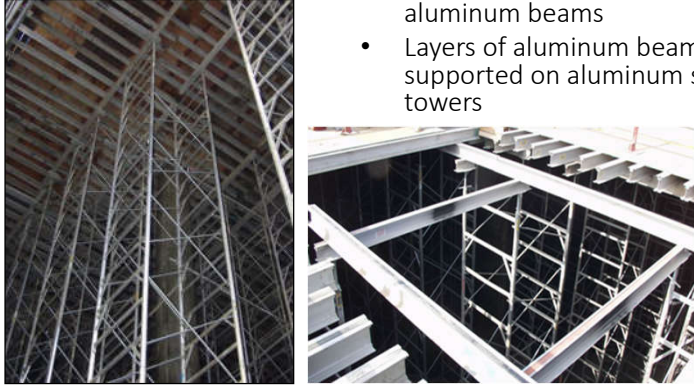
- Plywood formwork for concrete deck was supported on aluminum beams
- Layers of aluminum beams supported on aluminum shoring towers

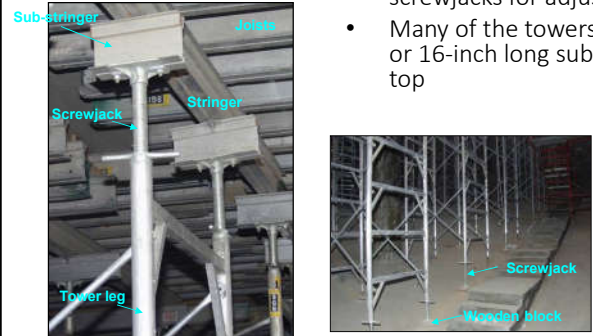
- Top and bottom of the towers had screwjacks for adjustable extension
- Many of the towers also had 12-inch or 16-inch long sub-stringers at the top

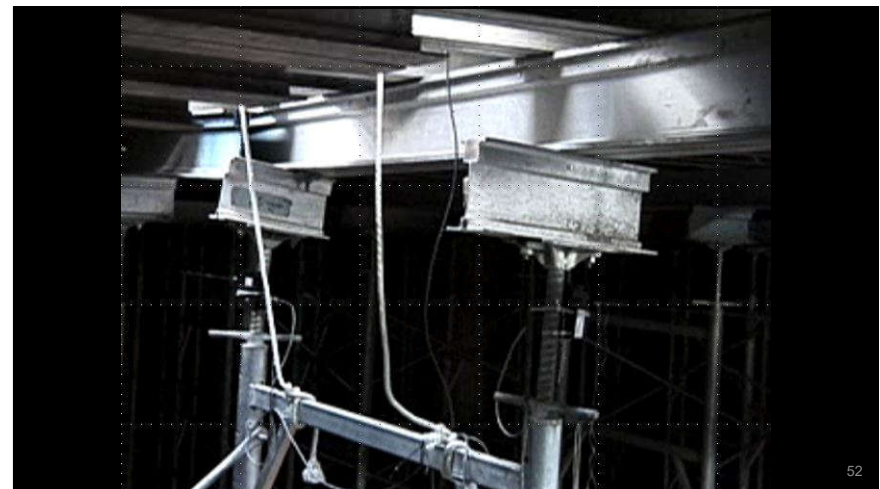
- Conducted full-scale field testing of exemplar shoring
- Towers were incrementally loaded to failure
- Failure due to sub-stringer web buckling leading to global buckling of scaffold towers
- The peak applied loads on legs with sub-stringers were
 - 14,850 lbs (Tower 1)
 - 13,750 lbs (Tower 2)
- Failure loads significantly below design ultimate of 22,000 lbs

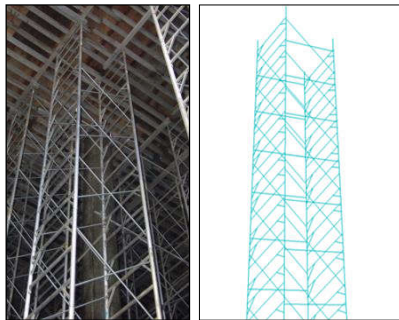
Finite-Element Analysis

A finite element model of shoring tower was prepared in ABAQUS

The model was used to study the effect of various factors on the strength and stability of the shoring towers
