AISC Live Webinars

Brittle Fracture: Another View

April 19, 2022

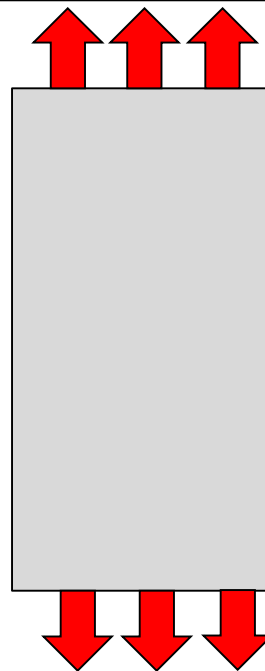
19

Basic Fracture Mechanics

Gross section will
eventually control.

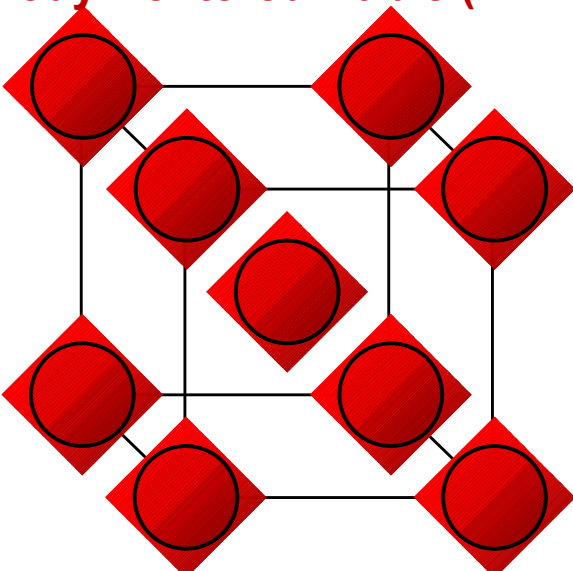
73

Body Centered Cubic (BCC)

Atomic Packing

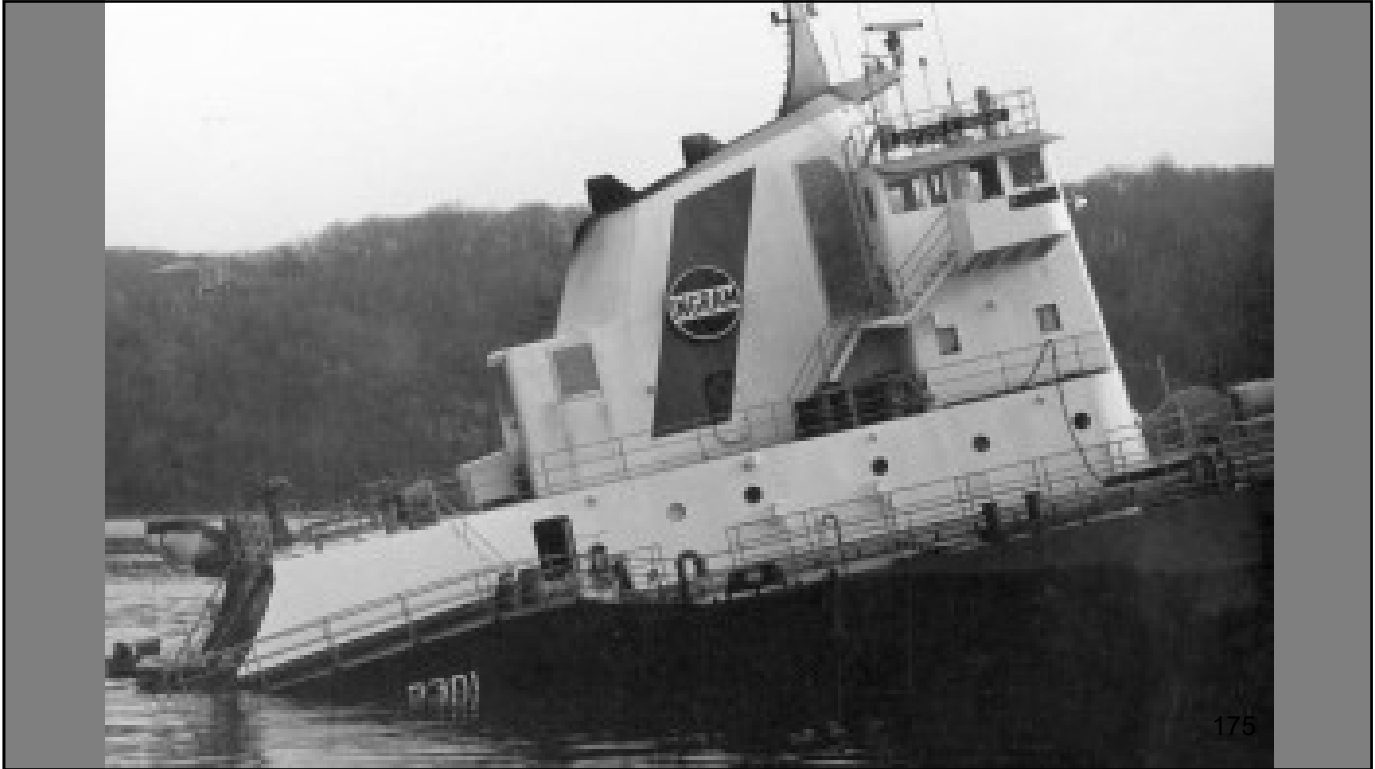
Martha R. Ingram Barge

- January 10, 1972
- 584 foot [178 m]
- Air temperature 45 °F [7 °C]
- In service for 9 months

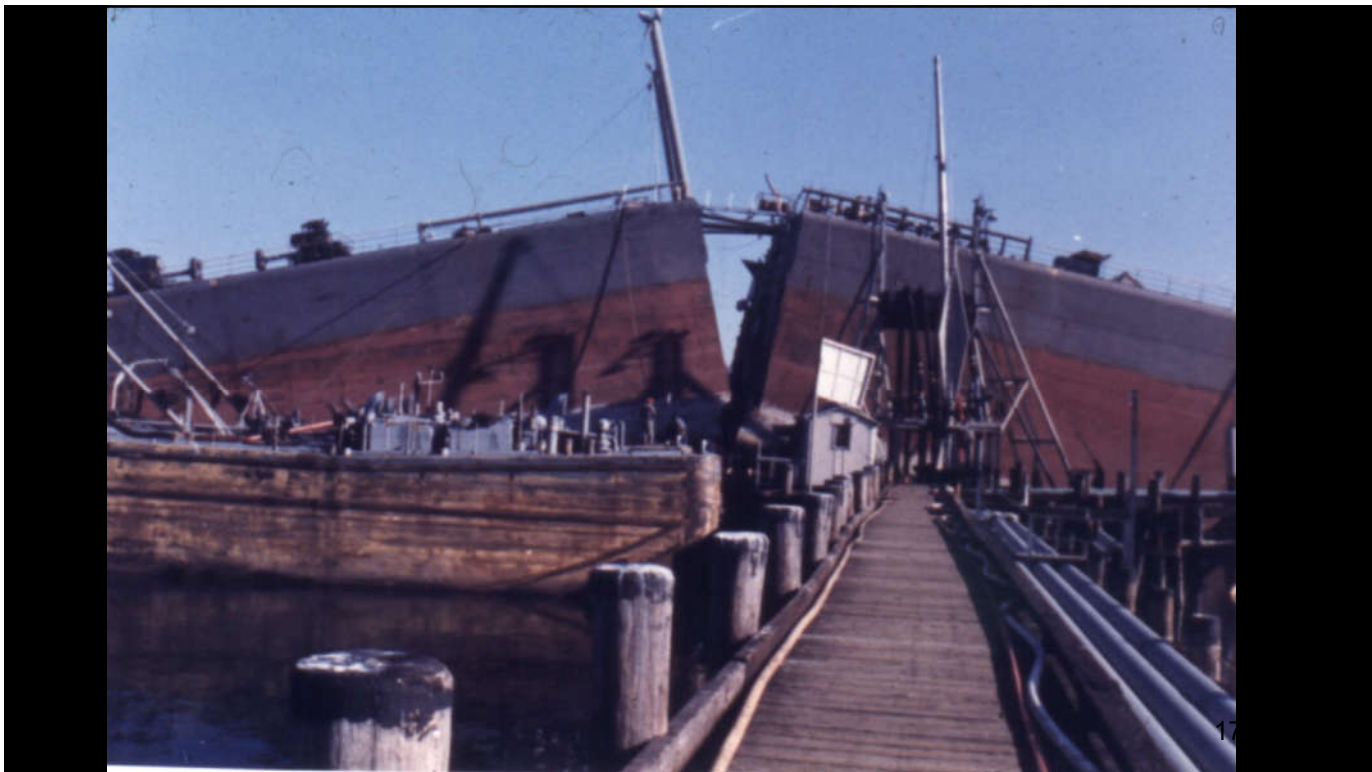
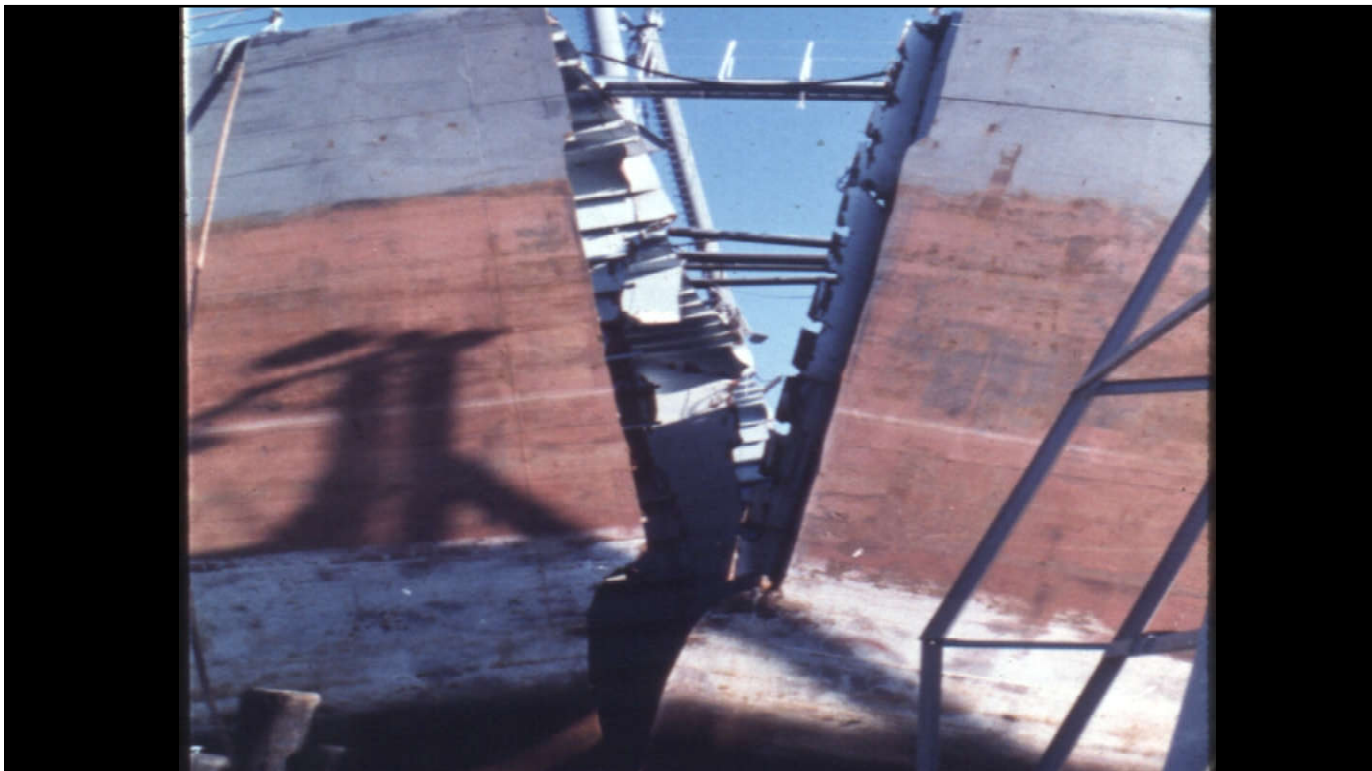
Martha R. Ingram Barge

- January 10, 1972
- 584 foot [178 m]
- Air temperature 45 °F [7 °C]
- In service for 9 months
- Unusual loading: 2.5X design load, 24 ksi [165 MPa]

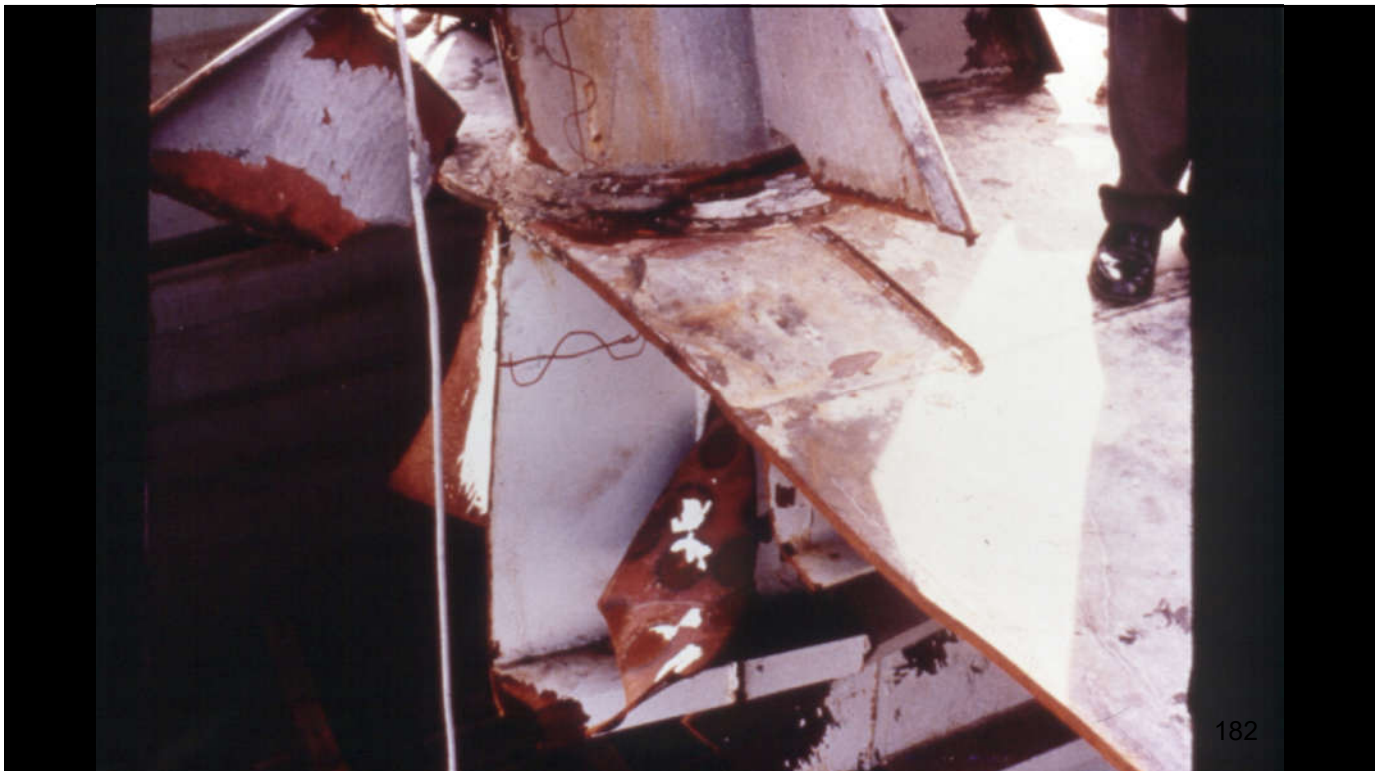
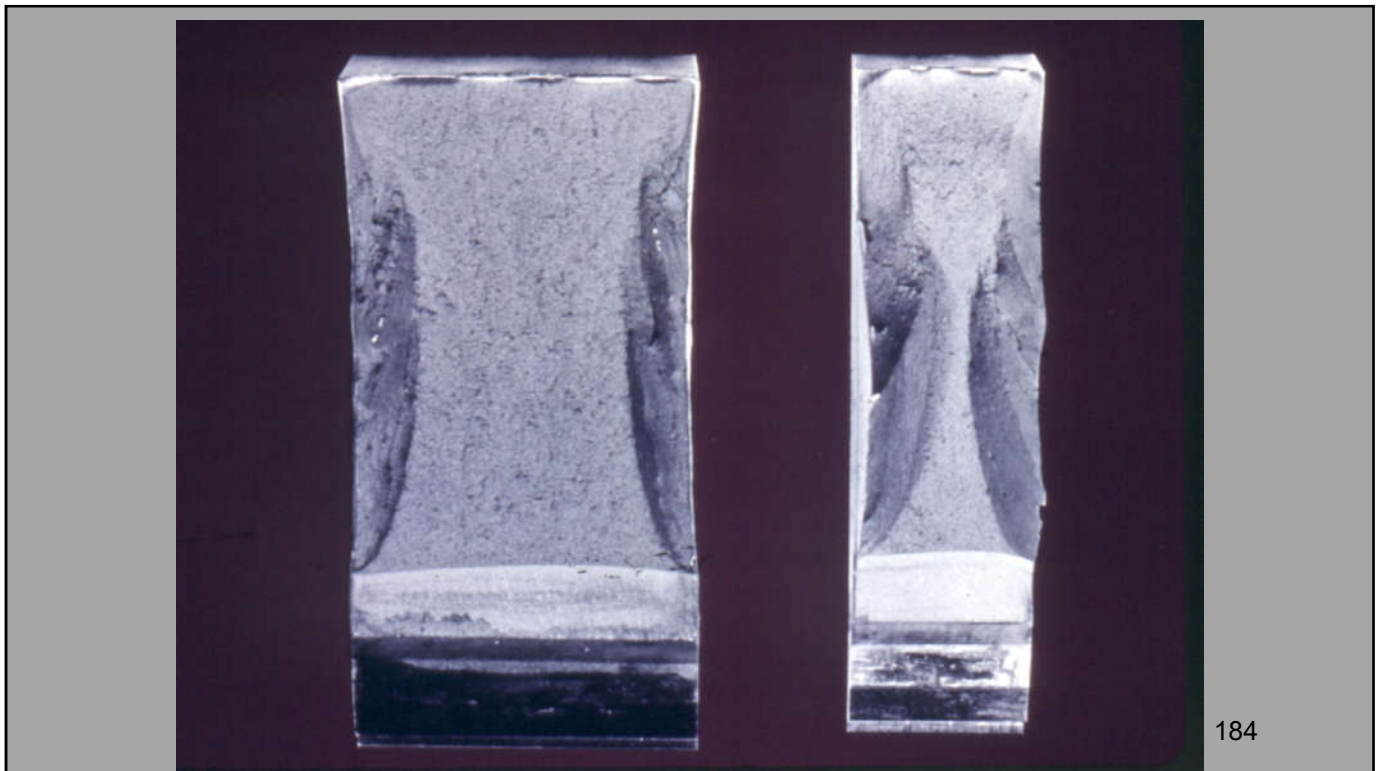
Martha R. Ingram Barge

- January 10, 1972
- 584 foot [178 m]
- Air temperature 45 °F [7 °C]
- In service for 9 months
- Unusual loading: 2.5X design load, 24 ksi [165 MPa]
- 55 ft-lbs [74 J] at service temperature
- No pre-existing flaws were observed

...the primary cause of failure was established to be an unusually high loading stress caused by improper ballasting at a highly constrained welded detail.

Thus, heavily constrained structures, such as the Ingram Barge, can fail under severe loads even though the inherent notch toughness and ductility may be very good. In contrast, well-designed simple structures can operate successfully at temperatures where their notch toughness may be very low. Thus, constraint and loading are the key factors in prevention of brittle fracture.

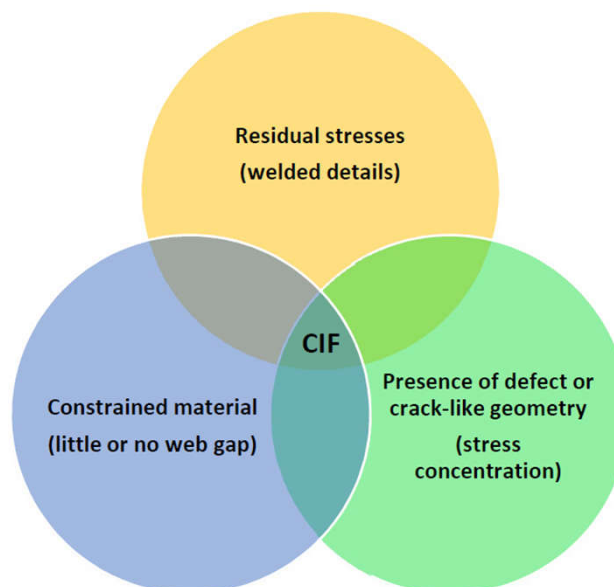
Figure 7.3 Defining characteristics of CIF details

There are three contributing elements to constraint-induced fracture, characteristic of all CIF-prone details, which when any one of the elements is missing, the likelihood of constraint-induced fracture drops dramatically. Figure 7.3 illustrates these elements, conceptually showing that the risk of CIF exists at the intersection of the three elements.

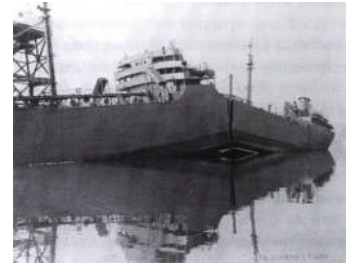
Liberty Ships

- Notches are bad
- Square corners are bad
- Notch sensitive steel is bad
- Good design is important
- Good fabrication is important
- Notch tough steel is helpful

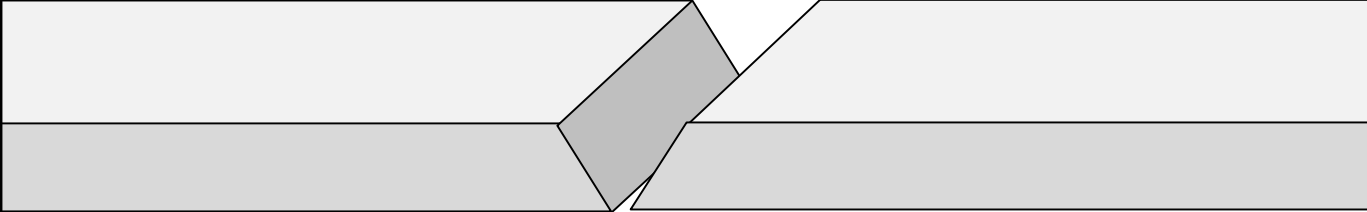
Flange Splice

3 in. (75 mm) thick, 10 in. (250 mm) wide,
Two 40 foot (13 m) lengths

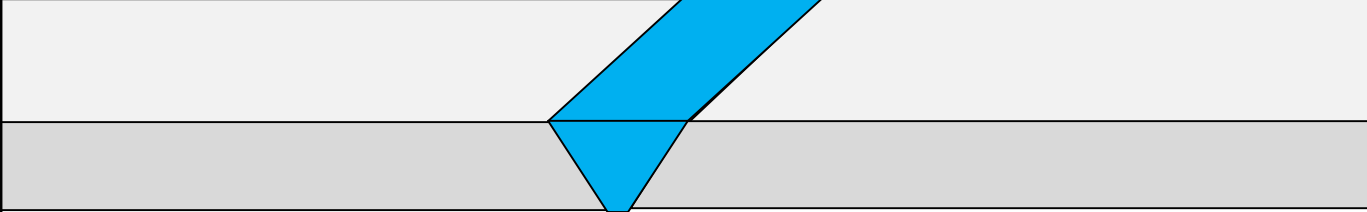
Flange Splice

LOW CONSTRAINT

3 in. (75 mm) thick, 10 in. (250 mm) wide,
Two 40 foot (13 m) lengths
