**Resilience and Repair of Major Steel Bridges**

December 2, 2021

# Resilience and Repair of Major Steel Bridges

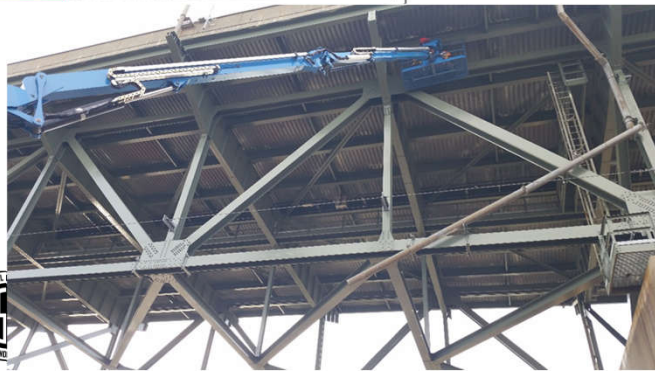
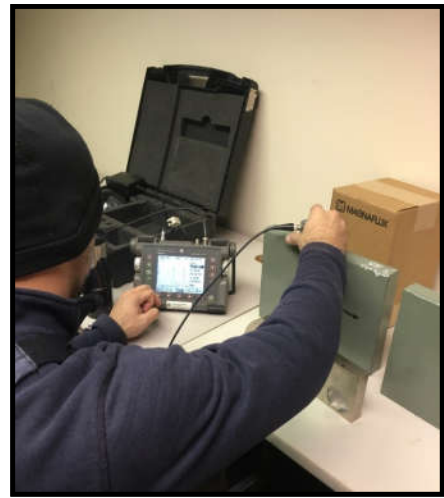
# Was This Problem Unique?

- 300 NDT tests performed by as many as 7 crews working simultaneously
- Daily reporting of results

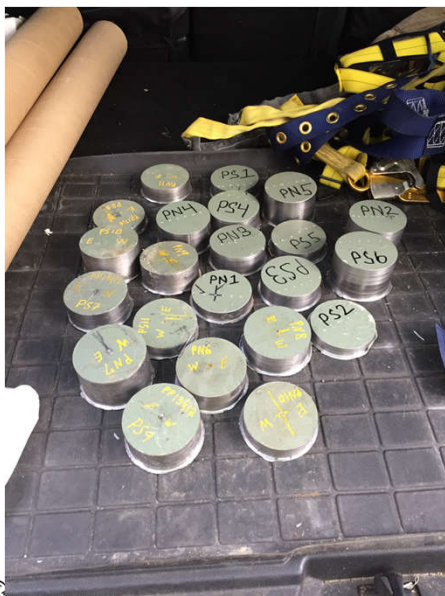
# Is the Material Suitable?

- 240 CVN samples
- 10 Tension
- 4 CT specimens
- Chemistry
- Examination of fracture surfaces

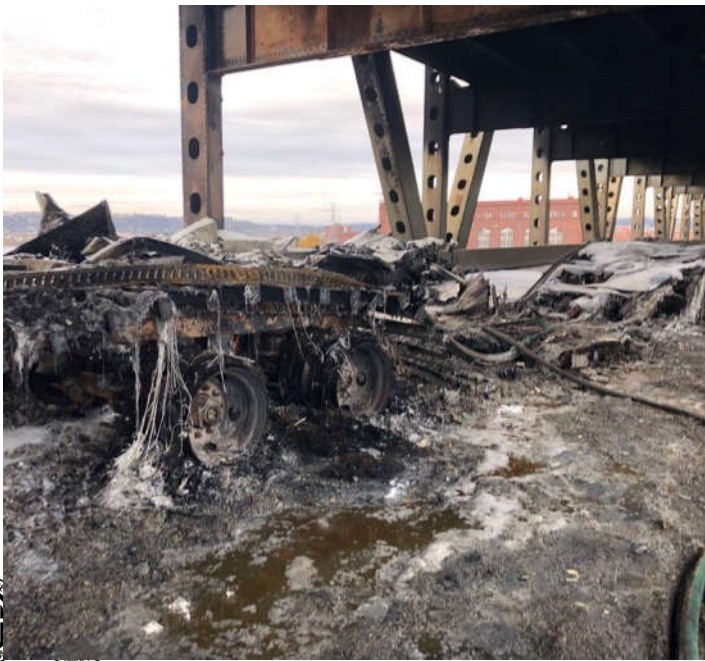
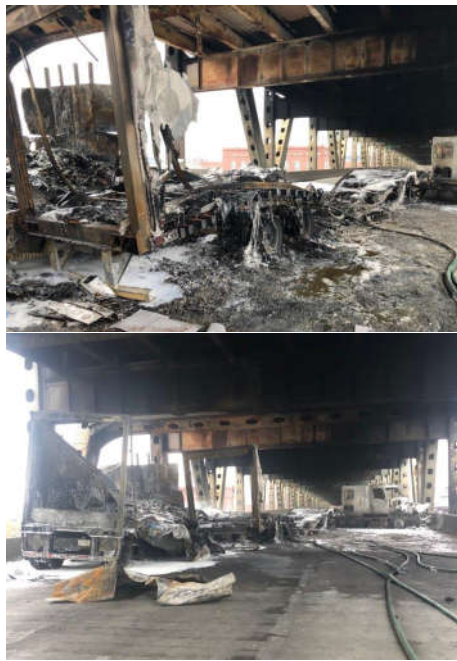
## The Aftermath

# Fire Damage

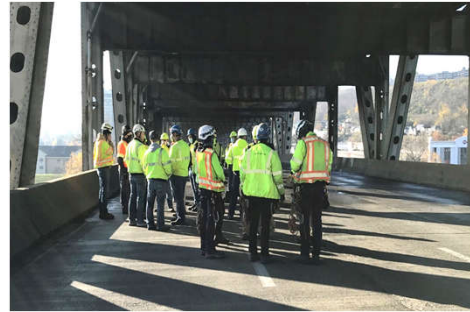
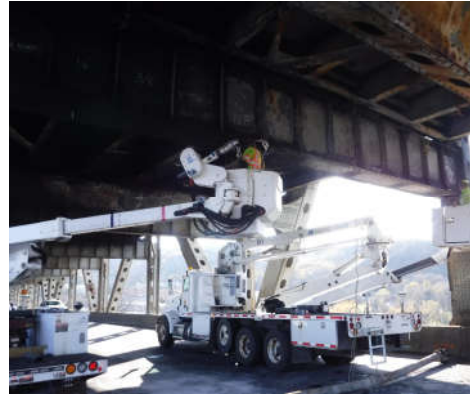
## Testing

- Concrete Cores
- Steel Cores (Microscopic Eval)
- Laser Induced Breakdown Spectroscopy
- Telebrineller hardness

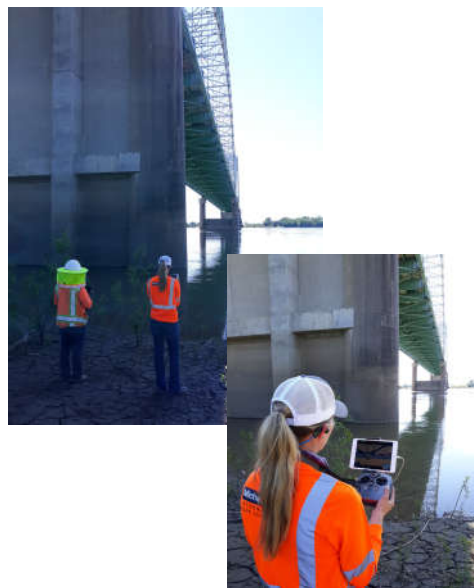
Viewing Area

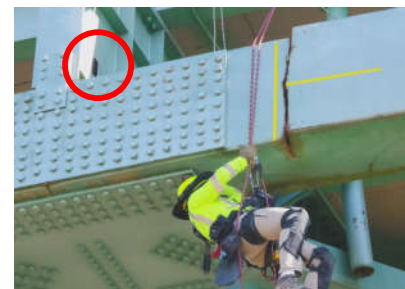
Fracture Location

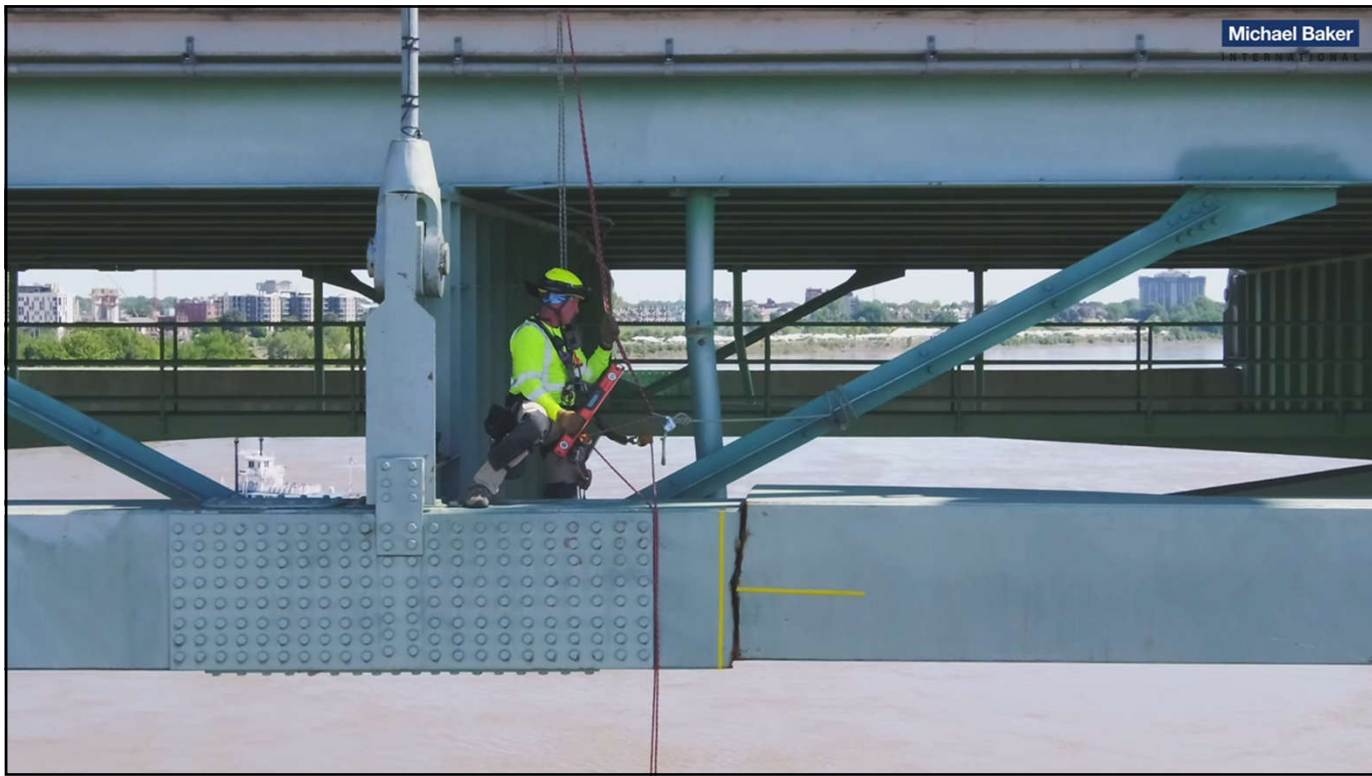
## Closer Look at Fracture

- Condition
- Measurements

- T1 steel = 100 ksi (+)
  - P/A deadload = 38ksi
- Fracture 113 in<sup>2</sup> -> 51.5in<sup>2</sup> (**45%!)**
  - P/A after Fracture = 83ksi
- Eccentric Loading
  - Refined Analysis
- Unknowns
  - Actual force in the tie

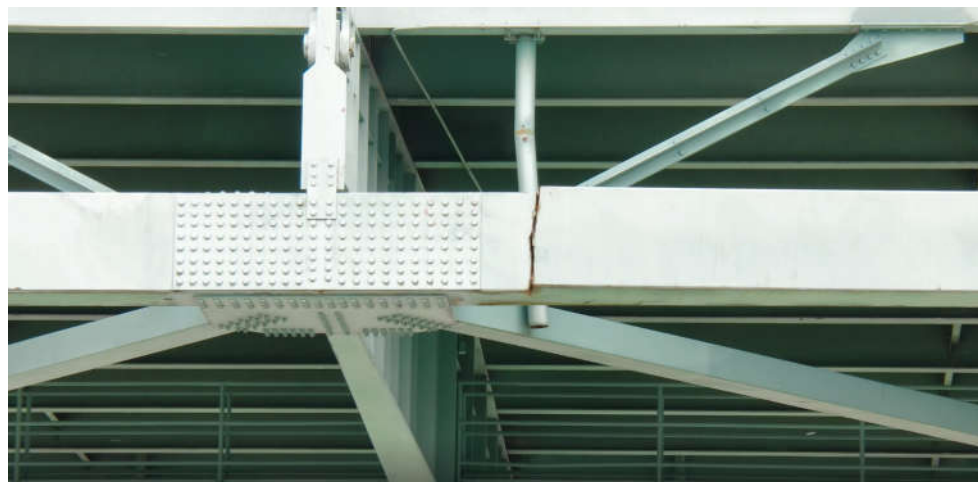
- Tie w/ 4,000 kips +/-
- Displaced laterally and rotated
- Limited reserve capacity
