Resilience and Repair of Major Steel Bridges  
December 2, 2021

## Resilience and Repair of Major Steel Bridges

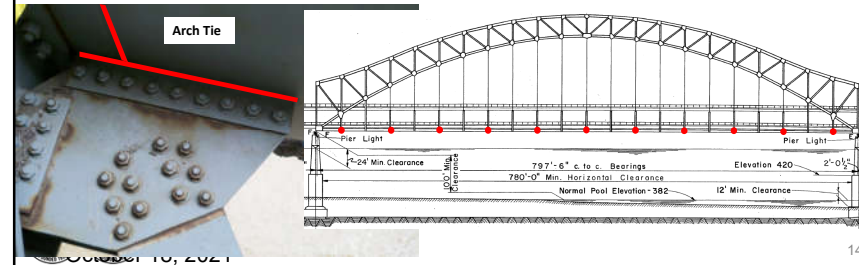
## Lateral Bracing Plates

- 11 panels x 2 plates per panel x 2 arch ties x 2 spans = 88 connection plates

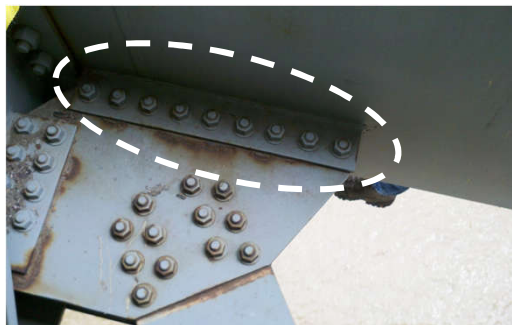
- Remove the lateral bracing plates to inspect what's behind them

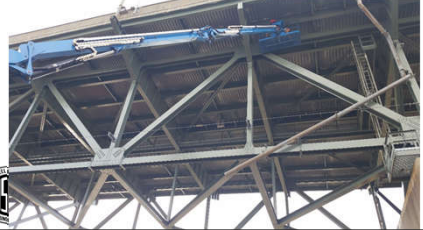
inspect both flanges both ends 3' straight beam UT [14x246]  
One line of trusses only is sufficient, i.e no hopping back and forth b/w 18 members - 2 flanges - 2 ends = 72 locations  
estimated 60 min per location = 72 hrs say 80 m.h. for pricing and sche

- 300 NDT tests performed by as many as 7 crews working simultaneously
- Daily reporting of results

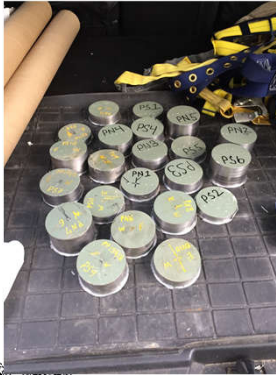
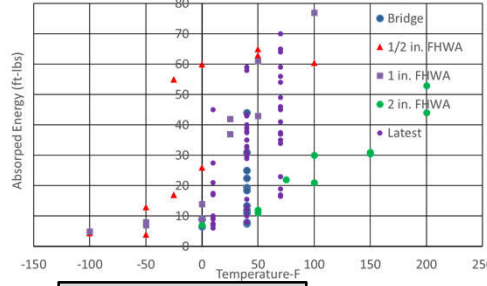
- 240 CVN samples
- 10 Tension
- 4 CT specimens
- Chemistry
- Examination of fracture surfaces

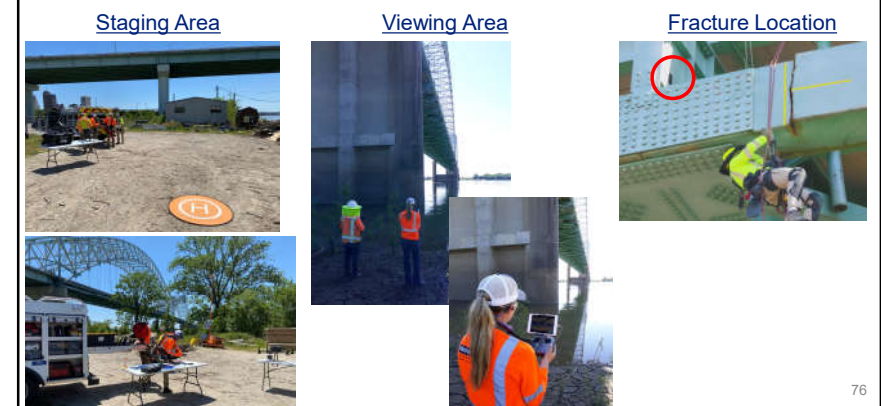
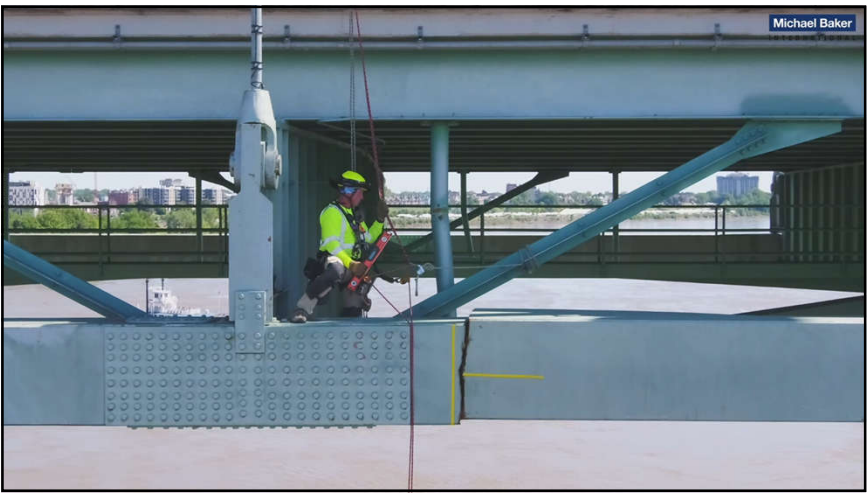
## Hernando de Soto – UAS Live Feed Inspection

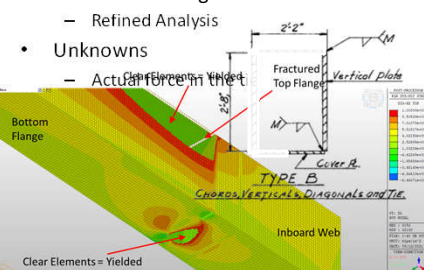
### How Bad is it?

- T1 steel = 100 ksi (+)
  - P/A deadload = 38ksi
- Fracture 113 in<sup>2</sup> -> 51.5in<sup>2</sup> (45%)
  - P/A after Fracture = 83ksi
- Eccentric Loading
  - Refined Analysis
- Unknowns
  - Actual force in the

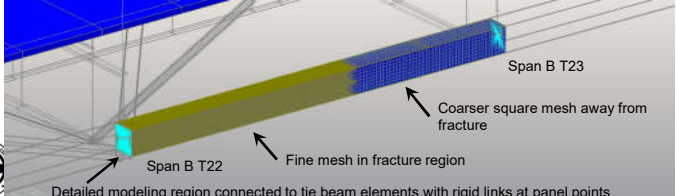
- **Local Model**
  - Modeled T22 and T23 upstream tie
  - Integrated in full 3D model
  - Connected using rigid links
  - Stability assessment of the current condition

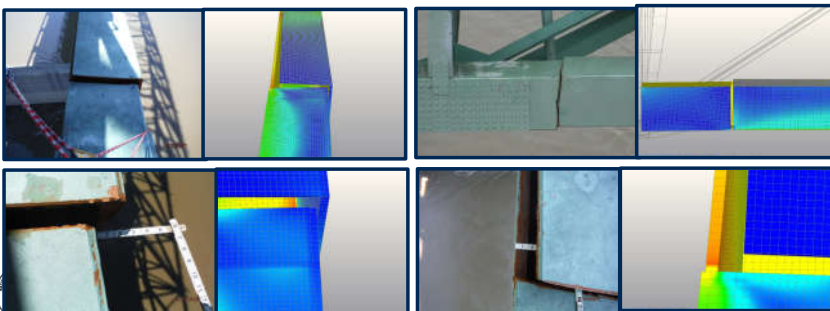
- **Stability assessment of the current condition**
